Pre-sale Building Inspection Report

PRE-PURCHASE BUILDING REPORT

Property Address	126 Kohinui Road, Parua Bay, Whareora, Northland, 0192, NZL		
Client	Ryan and Jessica Howard		
Date of Inspection	6th December 2023	Time	1:00 pm
Inspector	Jamie Mackintosh Licensed Building Practitioner Brick & Block		
LBP Number	116085		
Additional Information			
People Present	Inspector, Agent, Owner		
House Occupied	Yes

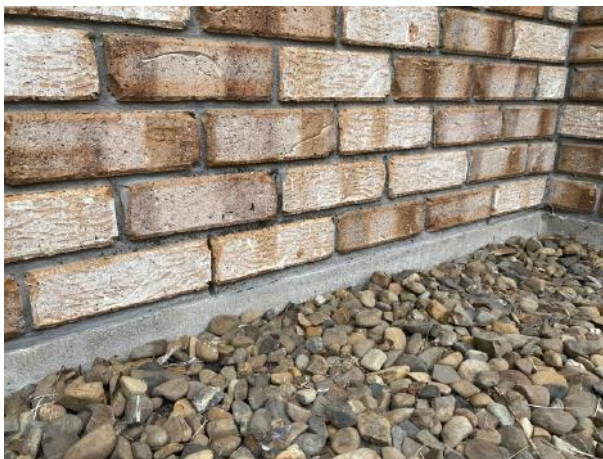
Photo 3

Masonry block foundation.

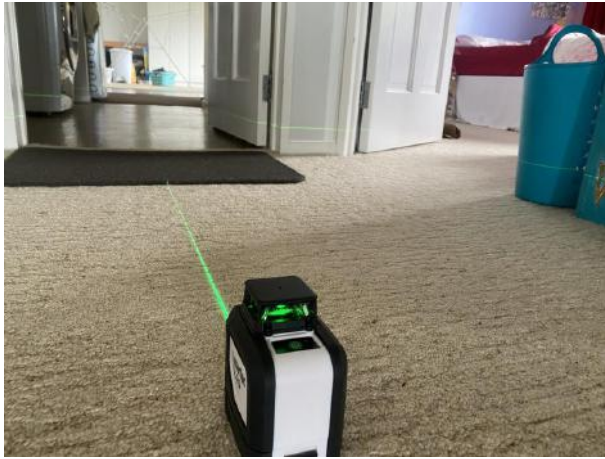
Photo 4

The floor levels were checked using a self-levelling laser. All within BRANZ recommendations.

Floor levels checked using a self levelling laser level.

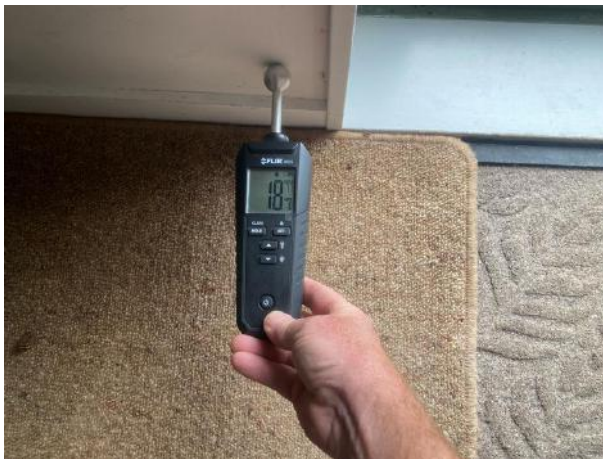
Photo 5

No elevated moisture readings were detected, all were normal at the time of the inspection.

No elevated moisture readings at the time of inspection.

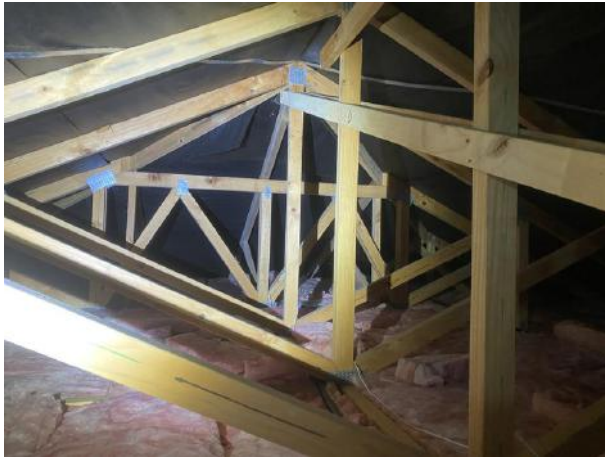
Photo 6

Roof space showing manufactured timber trusses.

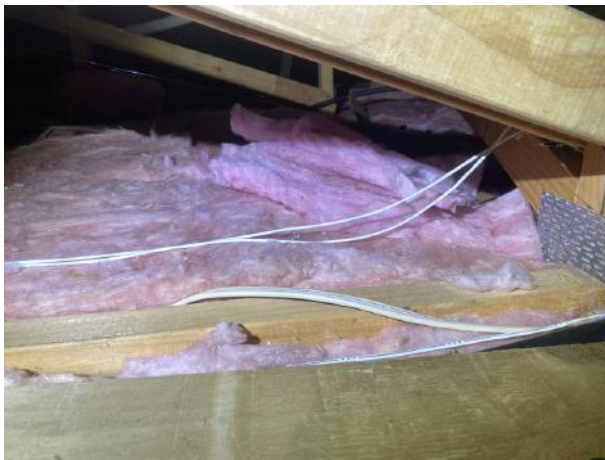
Photo 7

Roof space showing glass wool insulation and modern electrical wiring.

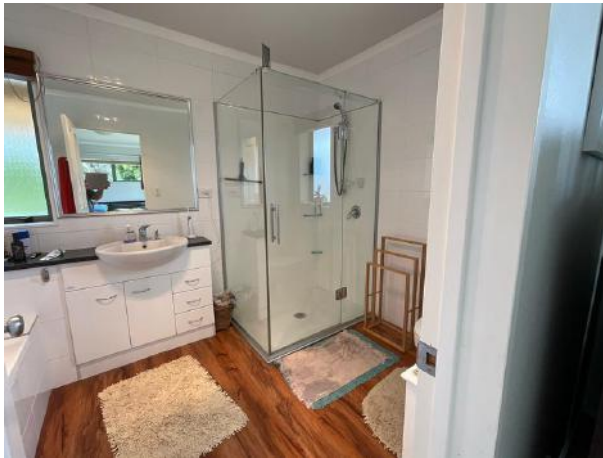
Photo 13

Shower - Enclosure. Corners of the shower are leaking.

Ensuite.

There is visible water leaking from the corners of the shower enclosure with water directed to these areas. Have a professional remove and install the pieces correctly to repair this issue.

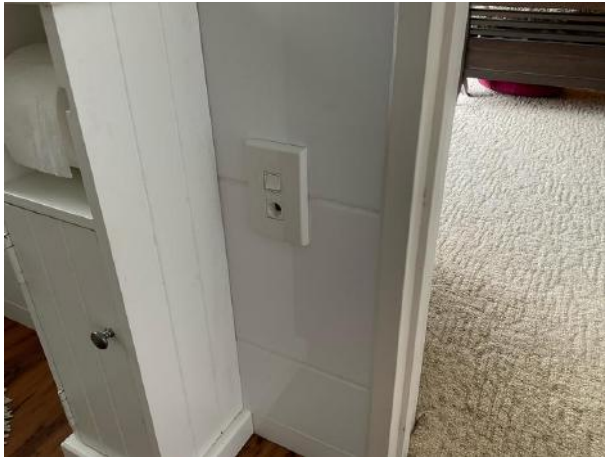
Photo 15

Provisions for a heated towel rail.

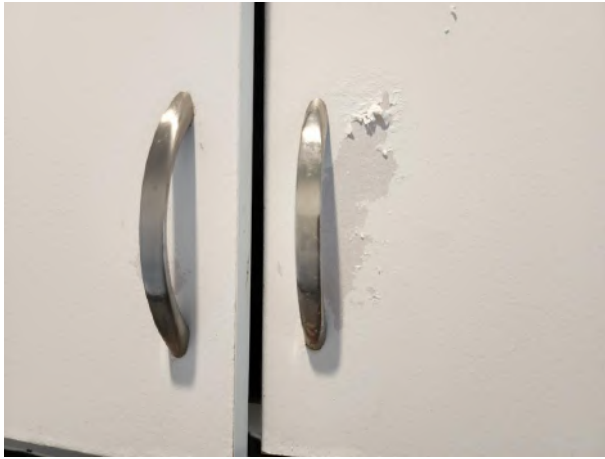
Photo 26

Paint flaking around the handles on the cabinets.

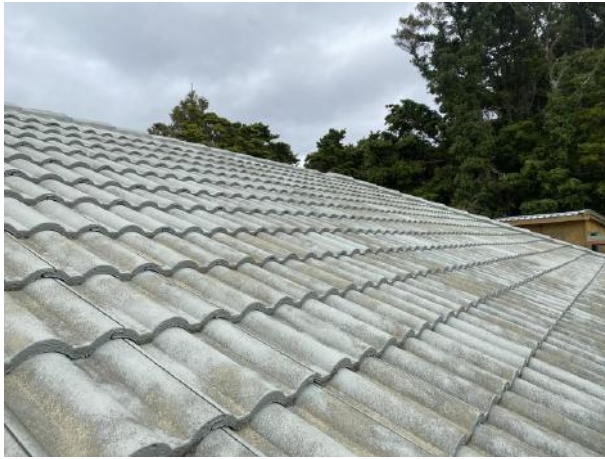
Photo 28

Areas of moss/lichen. Informed by owner roof has been treated with a moss/lichen treatment. Signs of the treatment working.

By including moss and mould treatment followed by painting or sealing as part of your regular maintenance routine, you can help preserve the integrity and appearance of your masonry tiled roof system. This proactive approach helps prevent potential damage and ensures the long-term performance of the roofing system.

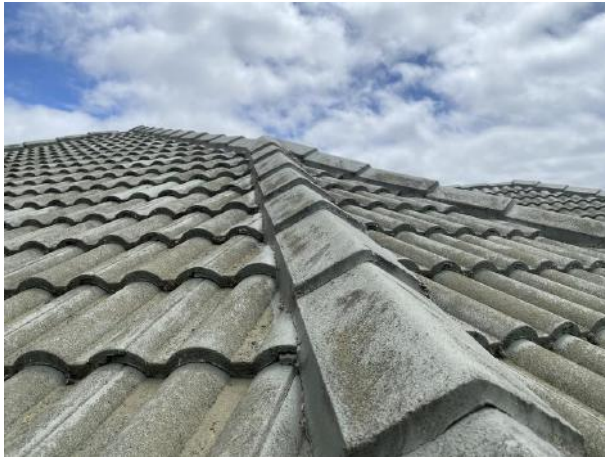
Photo 29

Example of a masonry hip flashing.

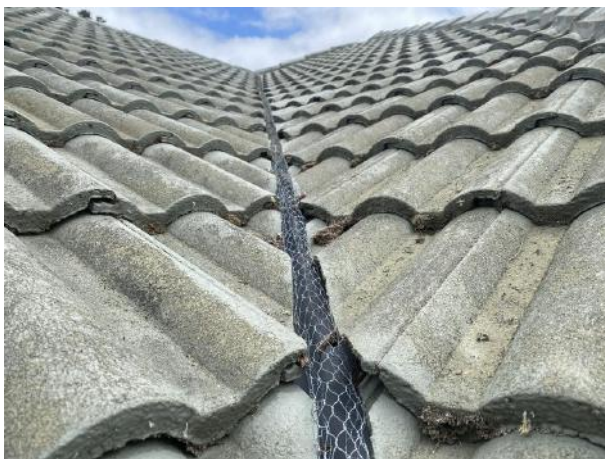
Photo 31

Example of a metal valley flashing with metal leaf guard.

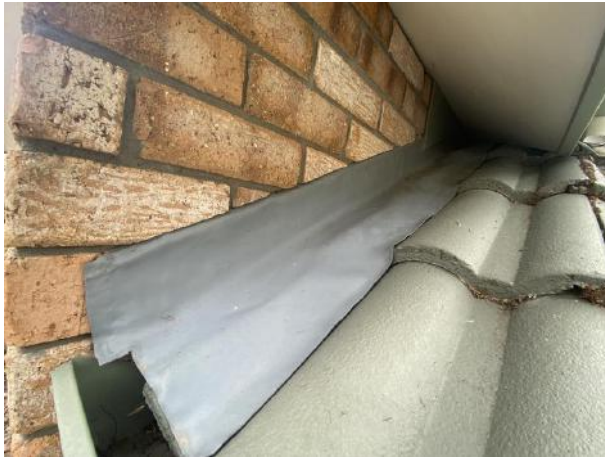
Photo 32

Example of a lead apron flashing. Functional.

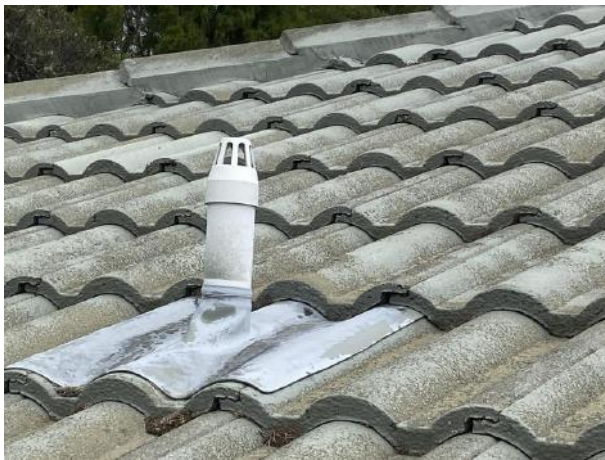
Photo 33

Vent penetration with lead flashing. Functional.

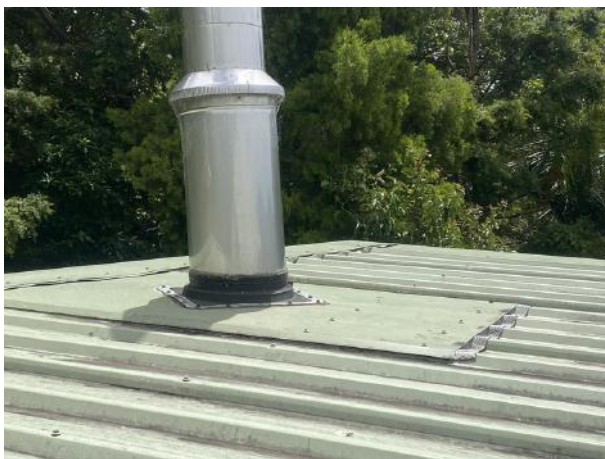
Photo 34

Studio flue penetration with rubber boot and metal back flashing. Functional.

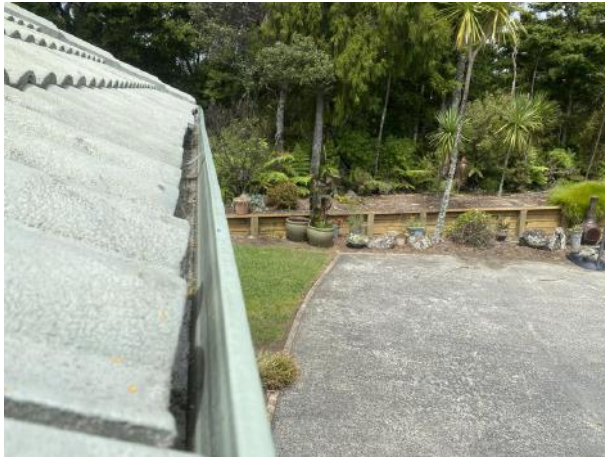
Photo 35

Example of profiled metal guttering. Clear at the time of inspection.

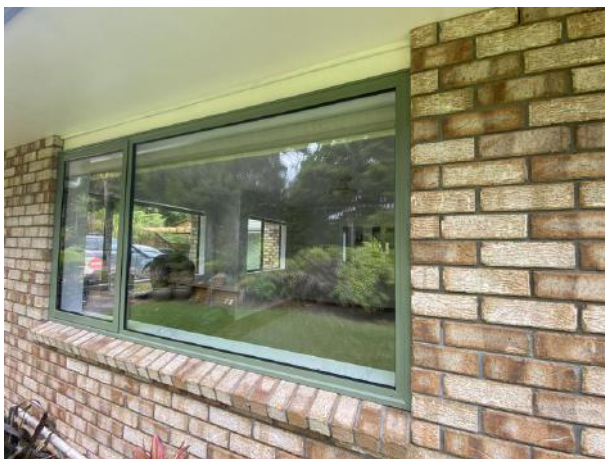
Photo 46

Example of aluminium joinery with metal head flashings.

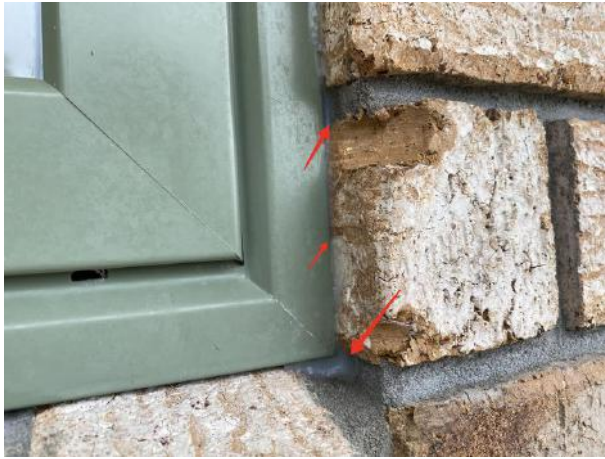
Photo 47

Joinery to brick side junctions have been siliconed sealed. Functional.

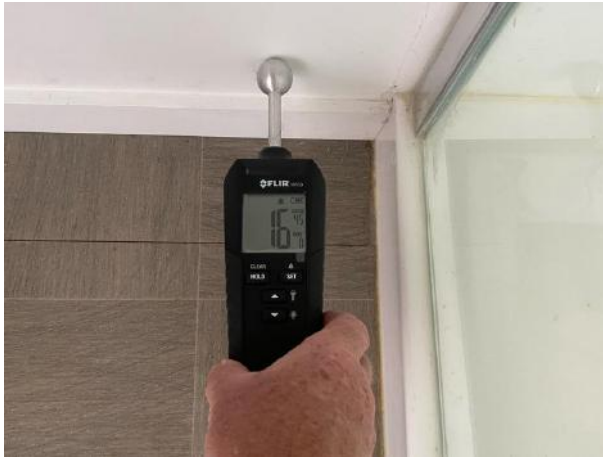
Photo 53

No elevated moisture readings at the time of inspection.

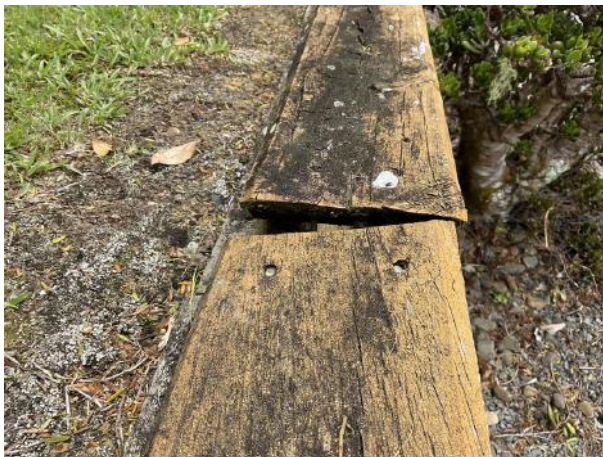
Photo 58

The top rail has twisted and come away from the post in some areas.

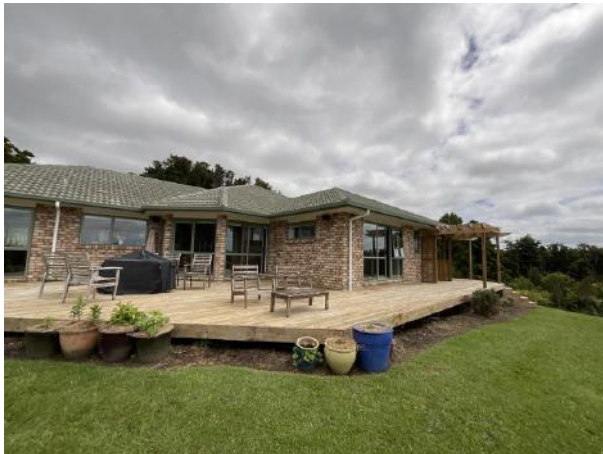
Photo 61

Timber deck located off the living room, dining room and bedroom one, on the east side of the house.

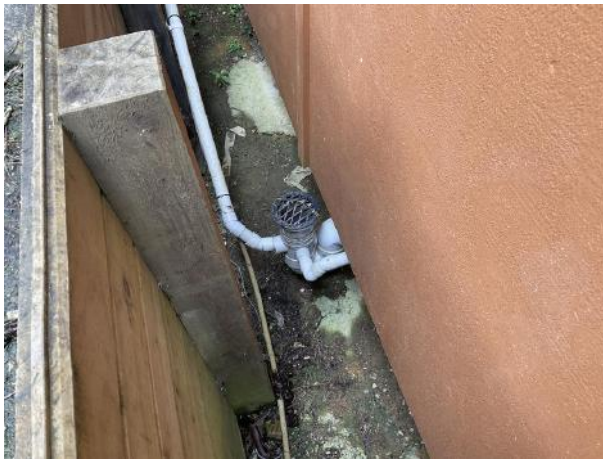
Photo 72

Gully trap located on the south side of the studio.

Gully traps should be accessible for cleaning and maintenance.

A deck may be built over a gully trap, but at least 600 mm of clear access space above the trap must be provided. This is for access to the gully trap for drainage inspections and maintenance in the event of blockages.

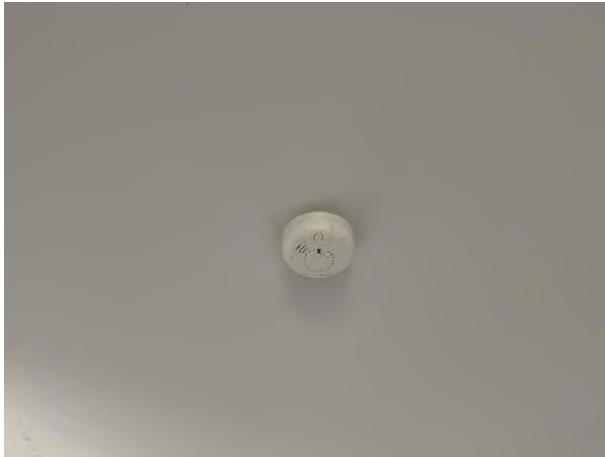
Photo 81

Smoke alarm located in the hallway and lounge.

It is recommended to install smoke detectors within 3 metres of any sleeping space and a minimum of one per level/story.

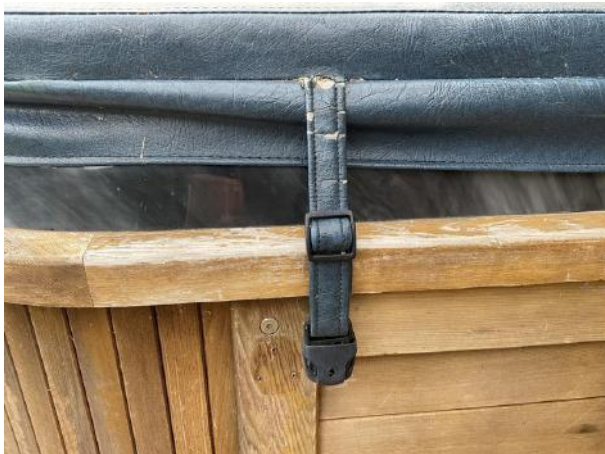
Photo 83

Spa pool lid is not lockable.

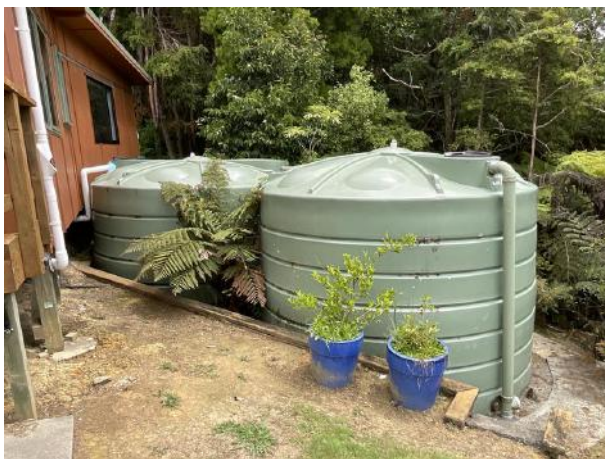
Photo 86

Plastic water tanks, located on the north side of the property. Water tank closest to the studio has a significant lean. May need re-levelling.

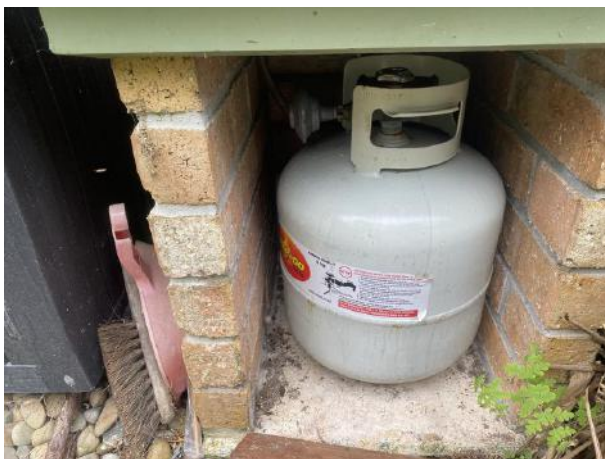
Photo 95

Gas bottle located on the south side of the house.

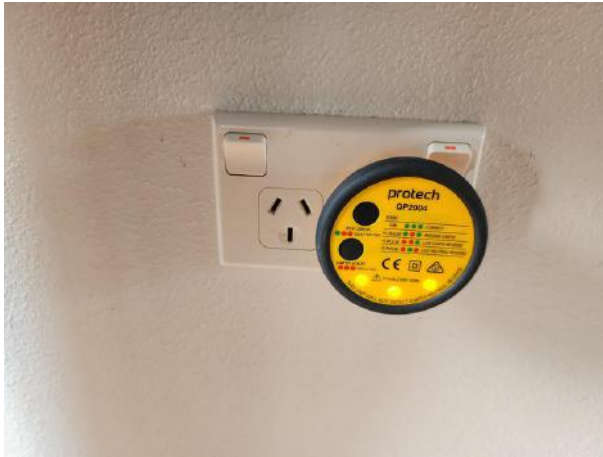
Photo 96

Example of electrical sockets tested throughout the dwelling.

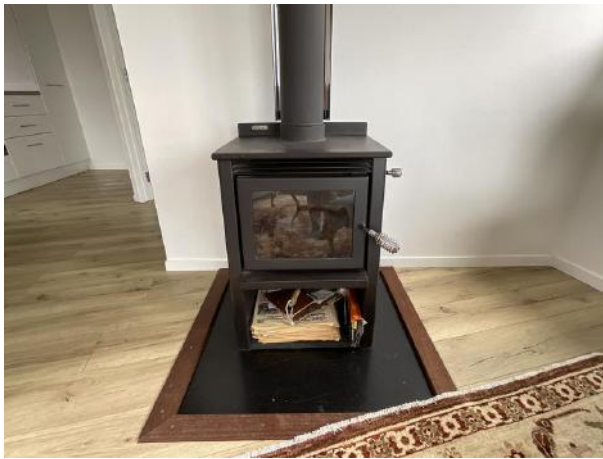
Photo 97

Metro freestanding wood burner located in the living room.

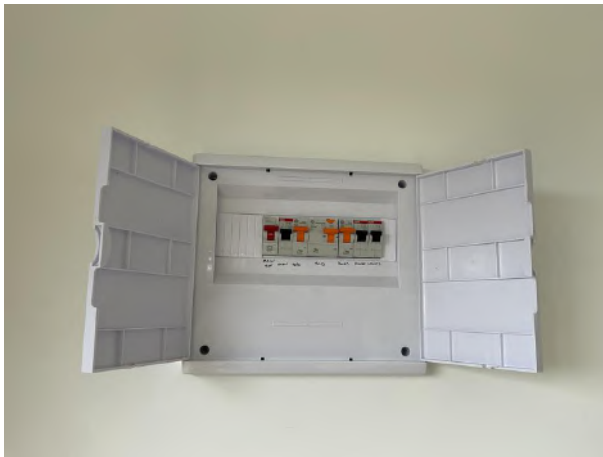
Photo 98

Distribution board located in the living room.

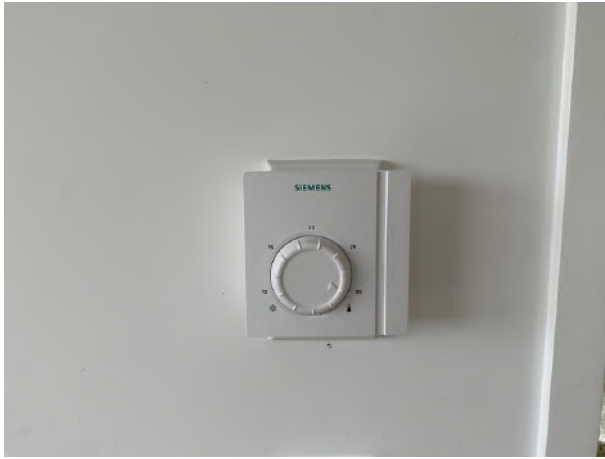
Photo 99

Siemens heating control panel located in the living room.

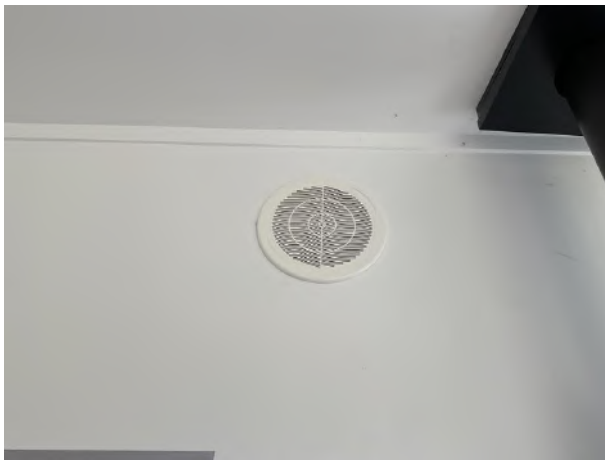
Photo 100

Heat transfer vent located in the living room beside the wood burner.

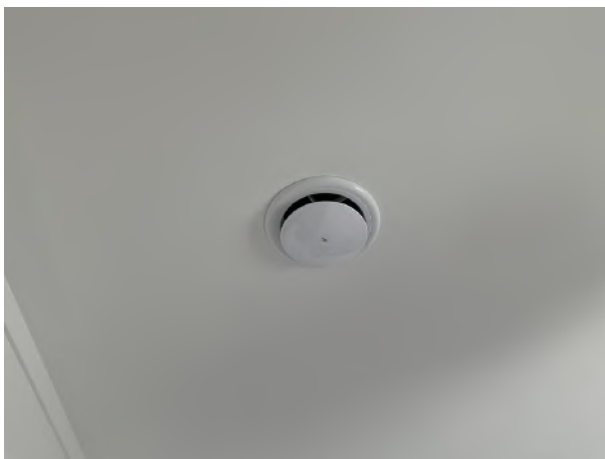
Photo 101

Heat transfer vent located in the bedroom.
