# Building Inspection Report

Client: Paul Sumich  
C/- Harcourts  
Location: 23 Tapper Crescent, Tikipunga  
Whangarei  
Inspection Date: 12/10/2021

RE: Building Inspection Report, 23 Tapper Crescent, Tikipunga, Whangarei.

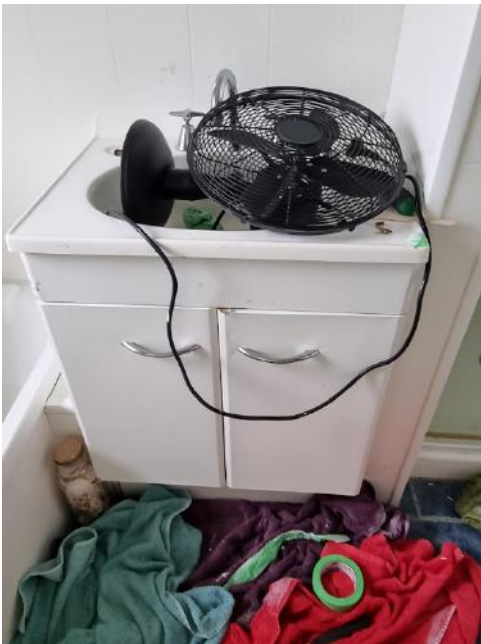
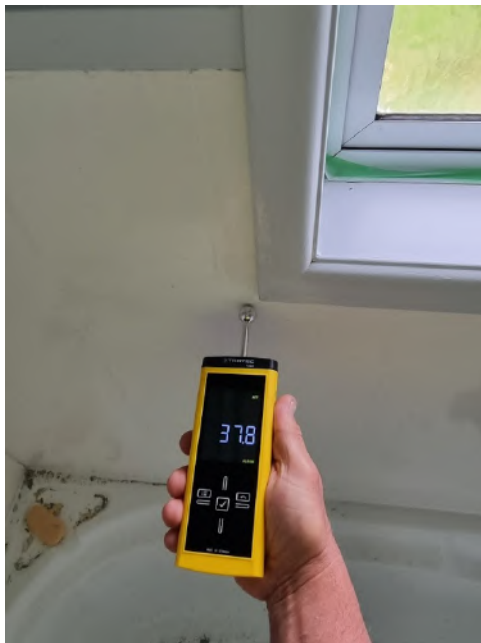
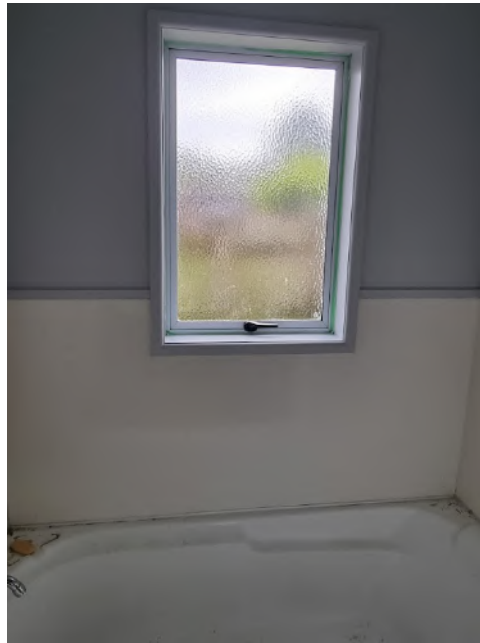
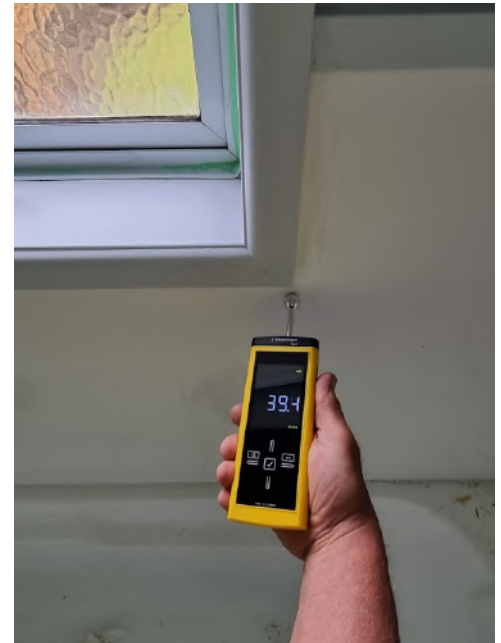
## Bathroom 1

Dwelling is in middle of renovations throughout

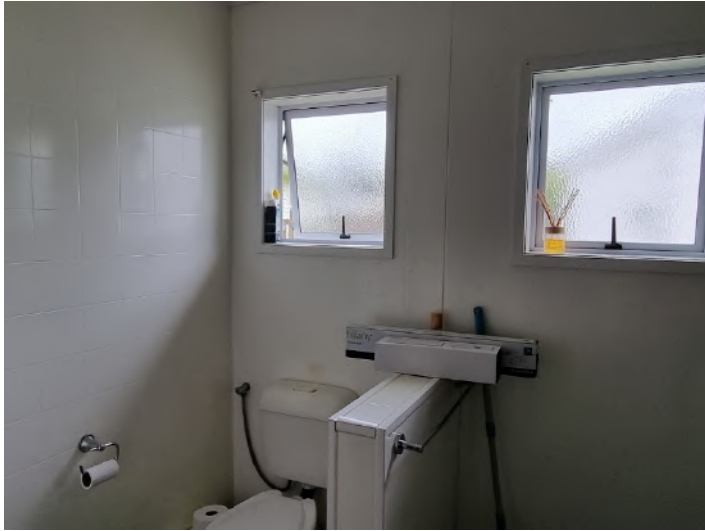
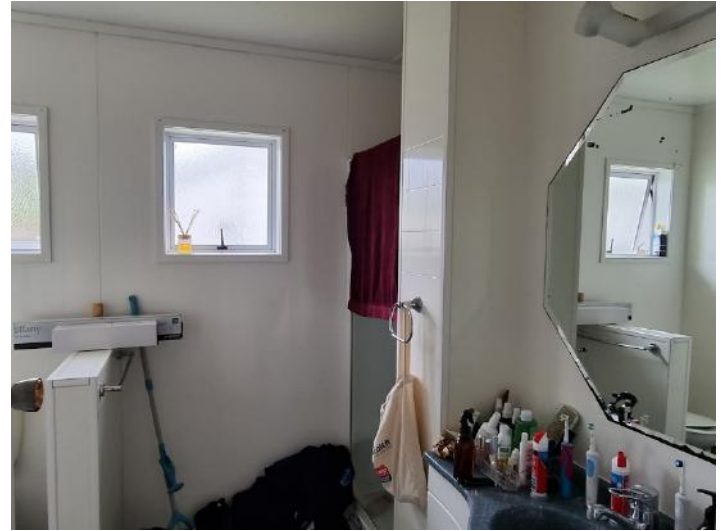
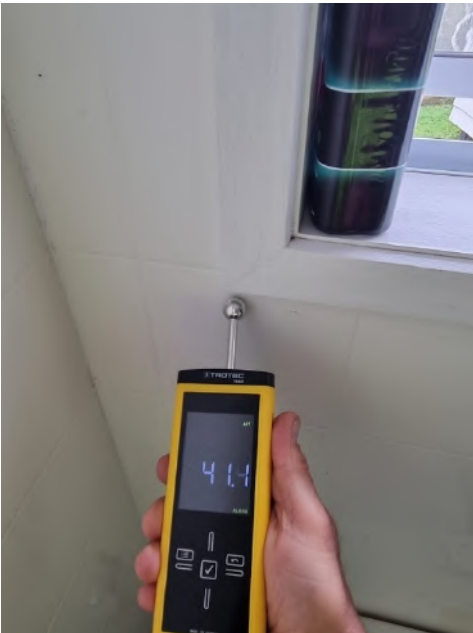
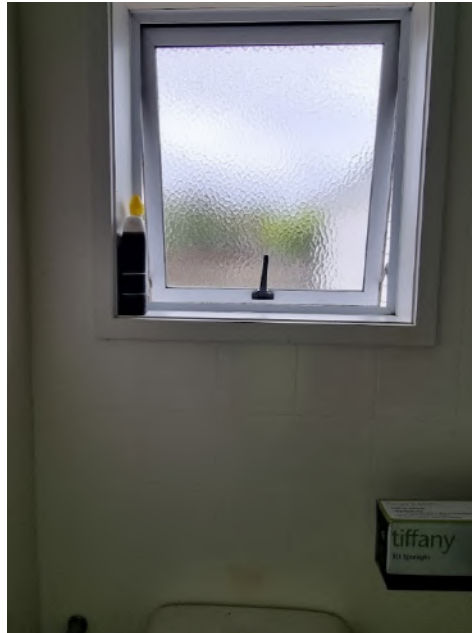
## Bathroom 2

Vanity shelving in bathroom 2 is in poor condition

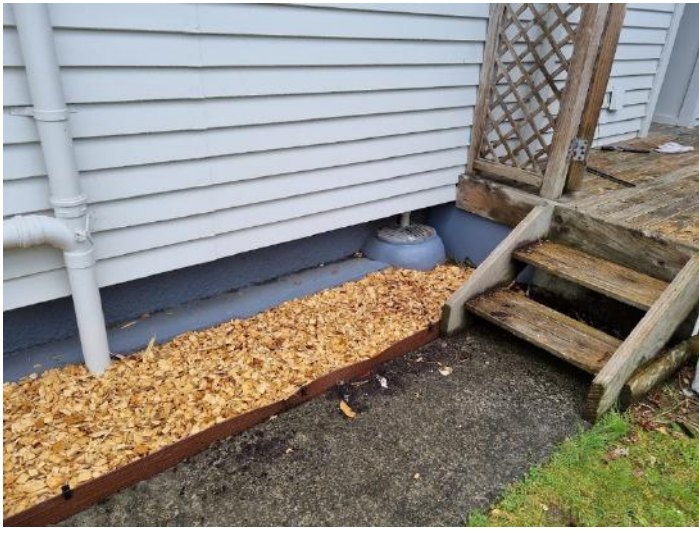
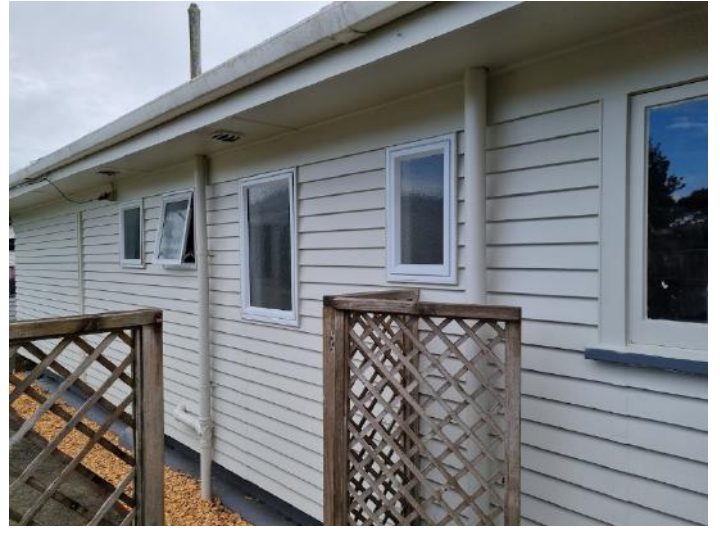
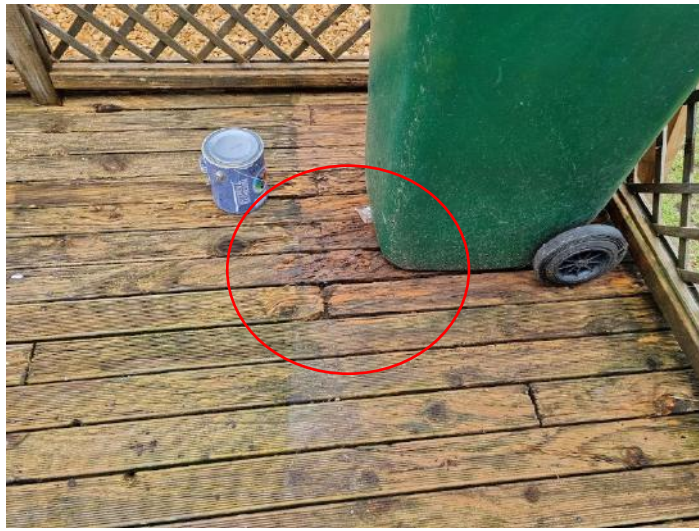
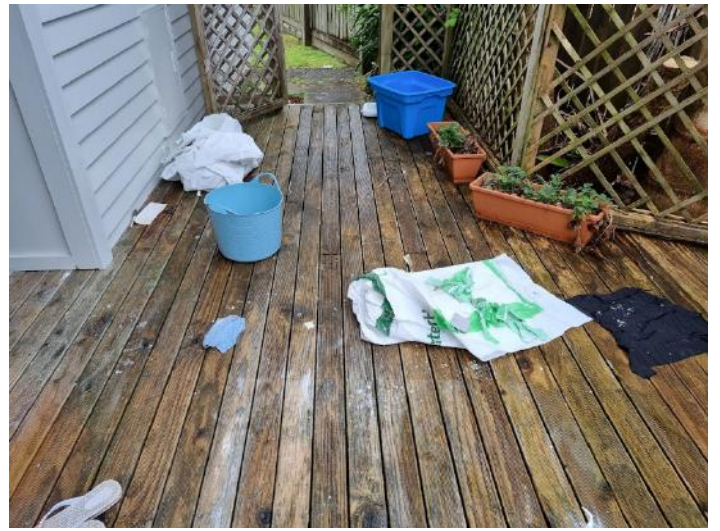
Timber decking to the back of the property is in poor condition – could do with replacing as rotting in places
