Building Report

Building Inspection Report

Client: Paul Sumich - C/o Bayleys
Location: 1 Kentia Lane, Whau Valley
Whangarei
Inspection Date: 01/02/2022

RE: Building Inspection Report, 1 Kentia Lane, Whau Valley, Whangarei.

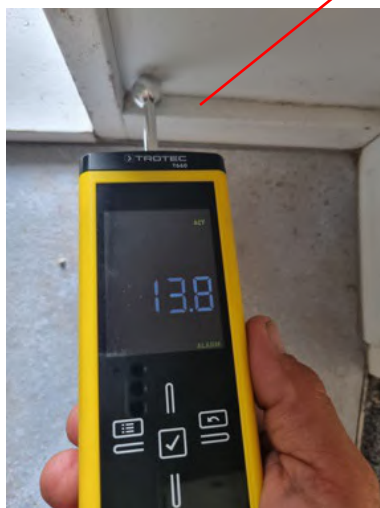
Front Entry

No access to check reading on left side

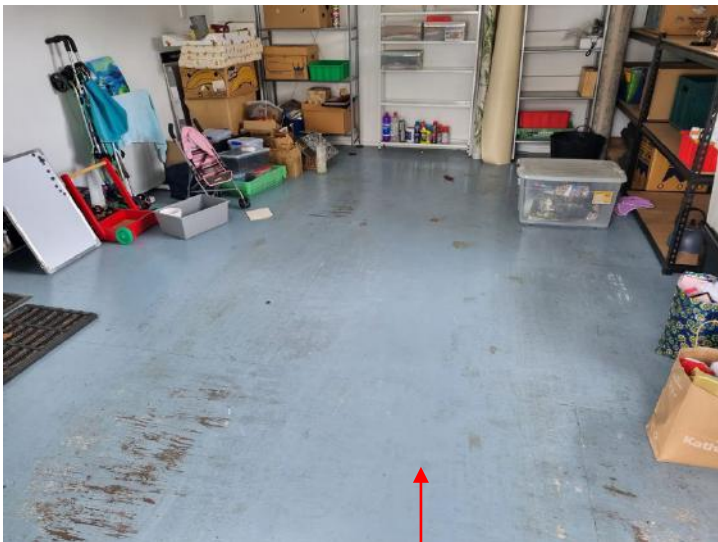
Power board located in garage

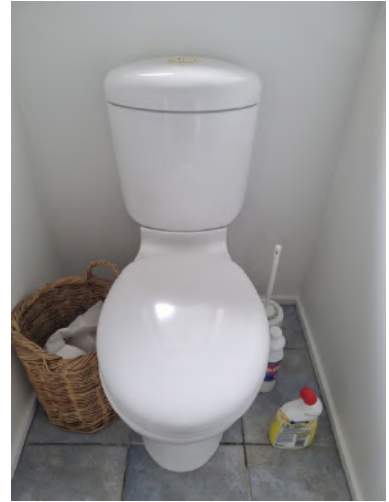
Toilet- separate

Separate toilet has no vent

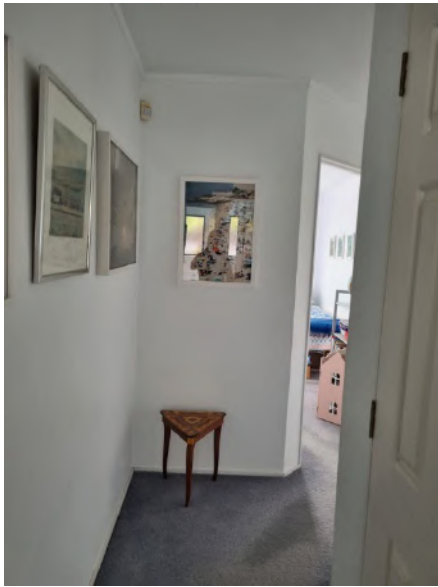
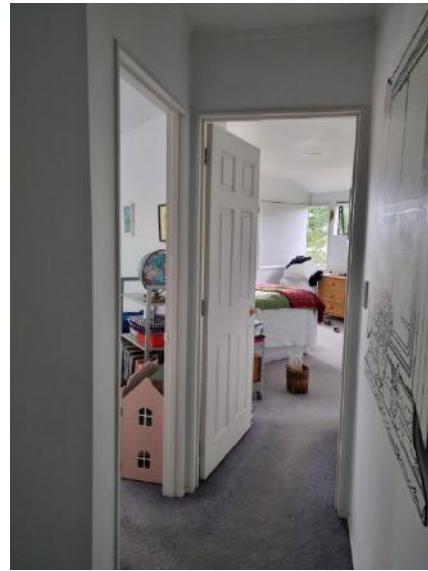
Hallway has surface crack in ceiling

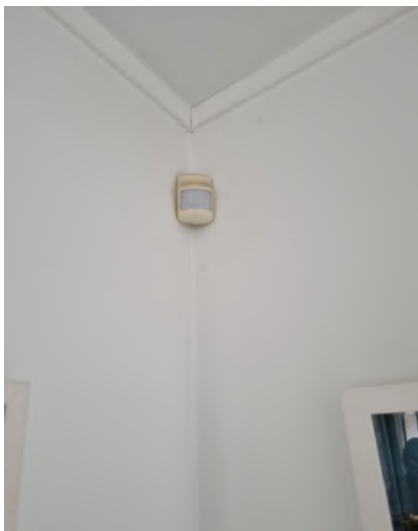
HRV Located in hallway outside Bedroom 1

Sensor is present in hallway but cannot find keypad

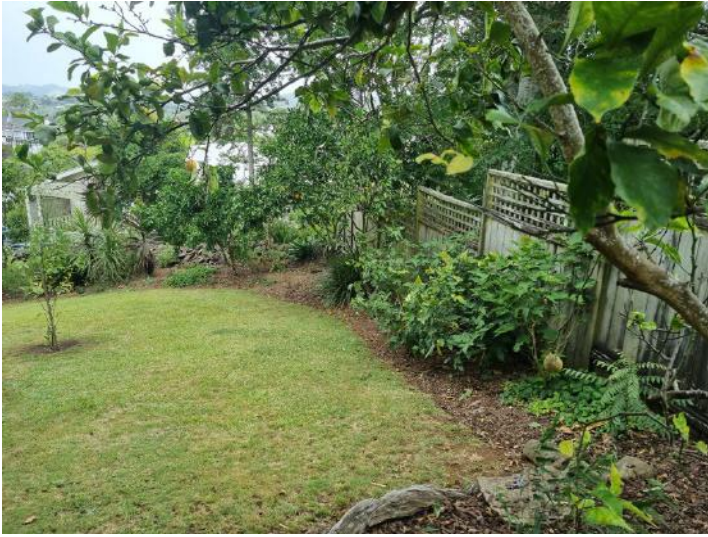
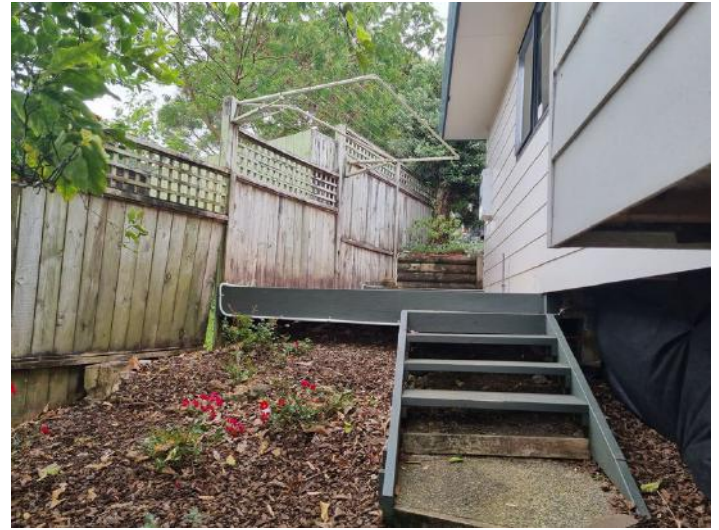
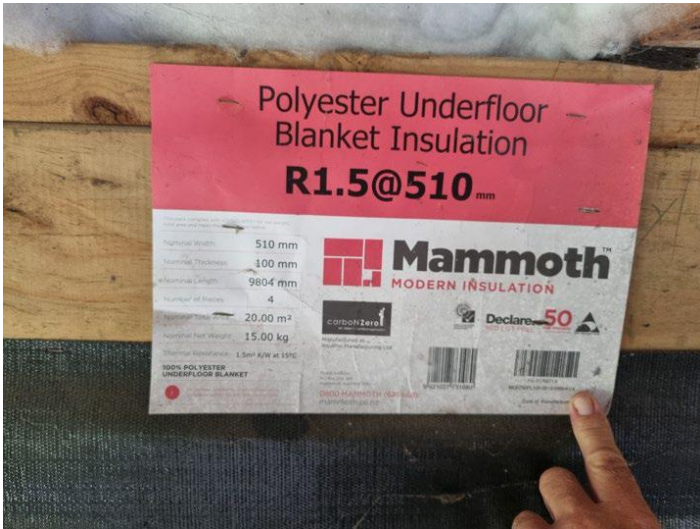
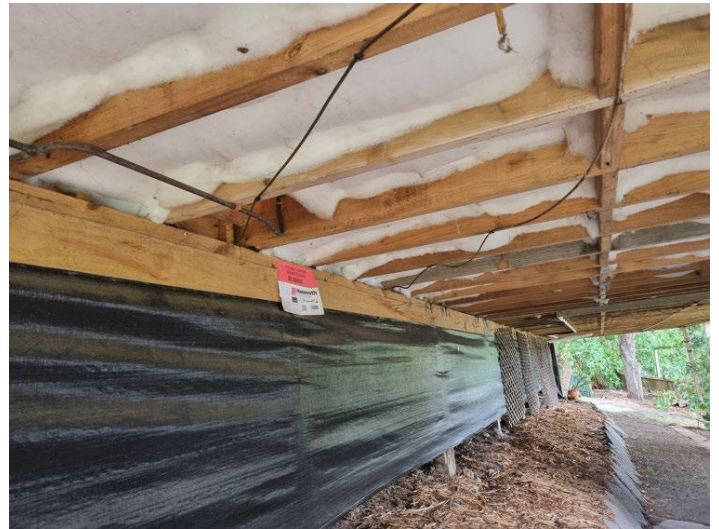
2x sheds under house were dry. Both are part board flooring and lined with fibrolite cladding.

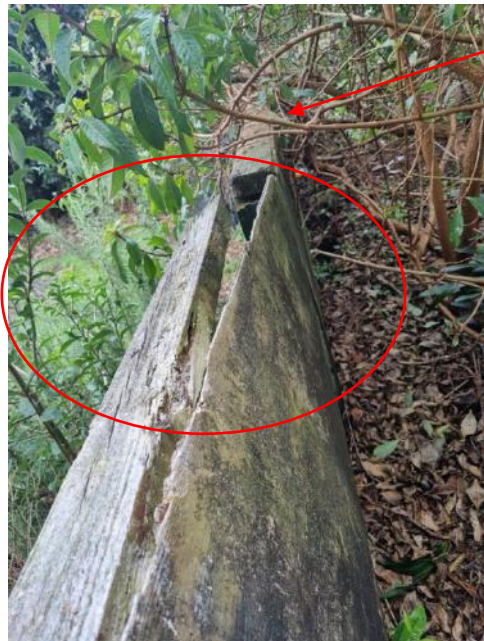
Plywood fence at rare needs maintenance

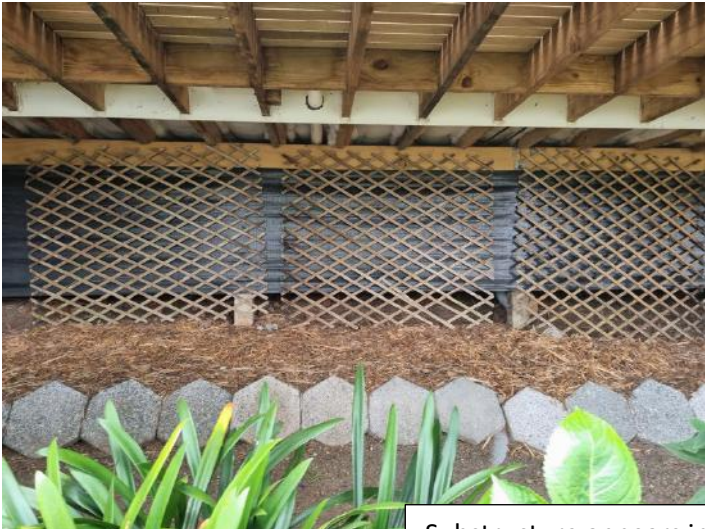
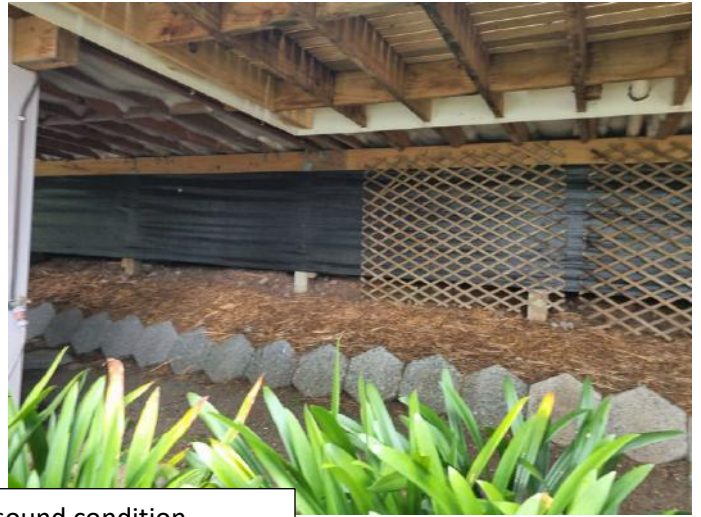
Substructure appears in sound condition

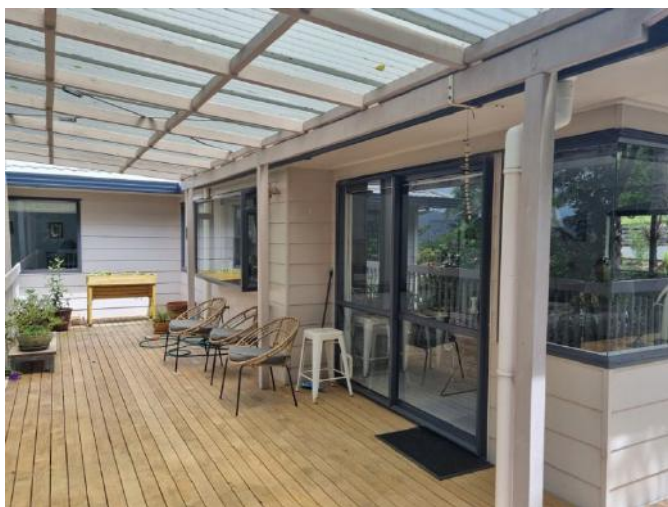
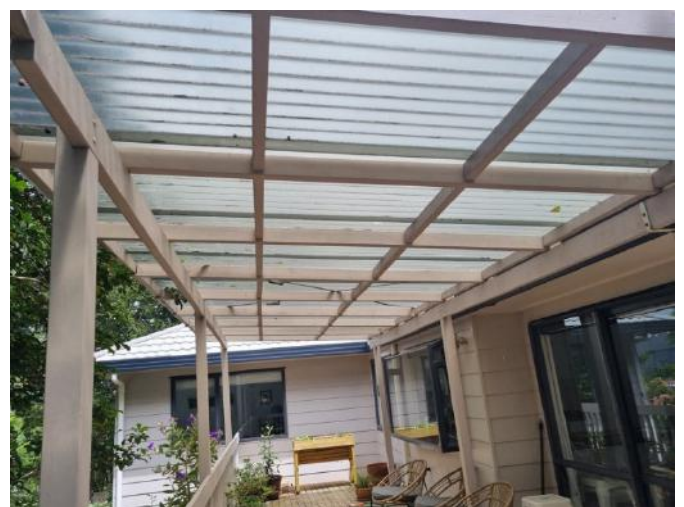
Small patch job has been done in corner of roof.

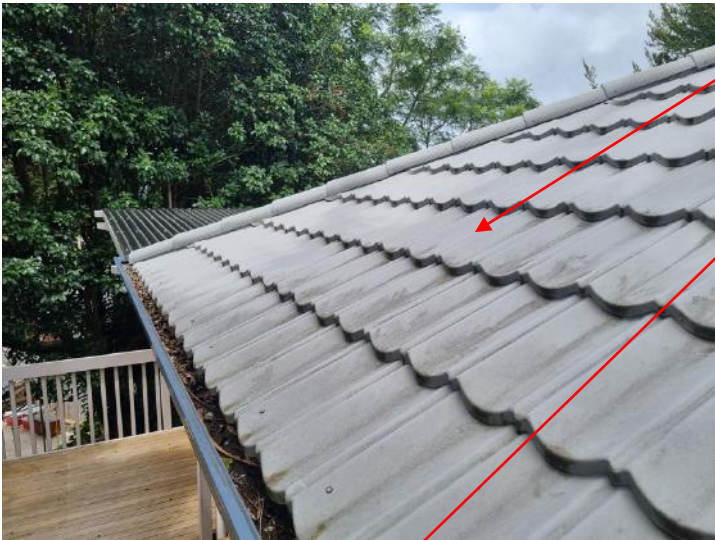
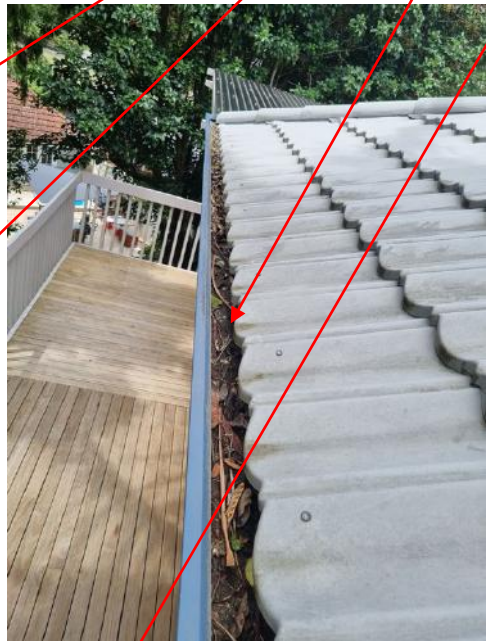
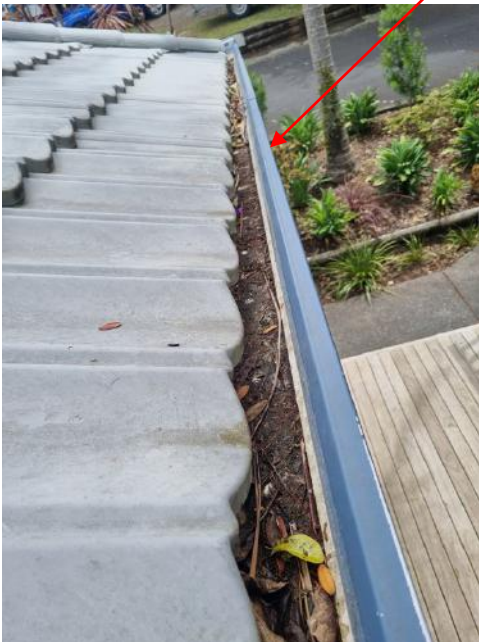
All guttering needs to be cleaned to avoid water backing up and going inside.

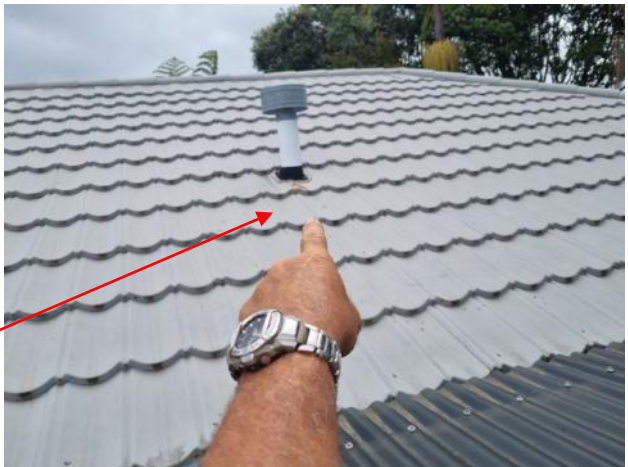
Roof tile has a bend, like someone has stood on it
