# Building Inspection Report

Client: Paul Sumich  
Location: 103 Maunu Road, Woodhill  
Whangarei

Inspection Date: 20/10/2021

RE: Building Inspection Report, 103 Maunu Road, Woodhill, Whangarei.

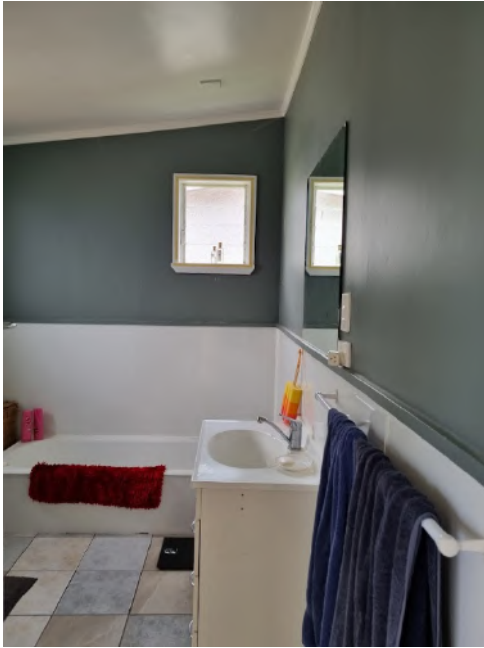
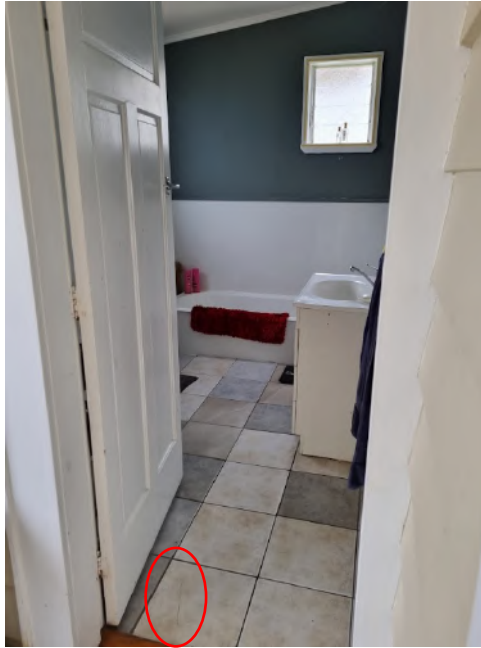
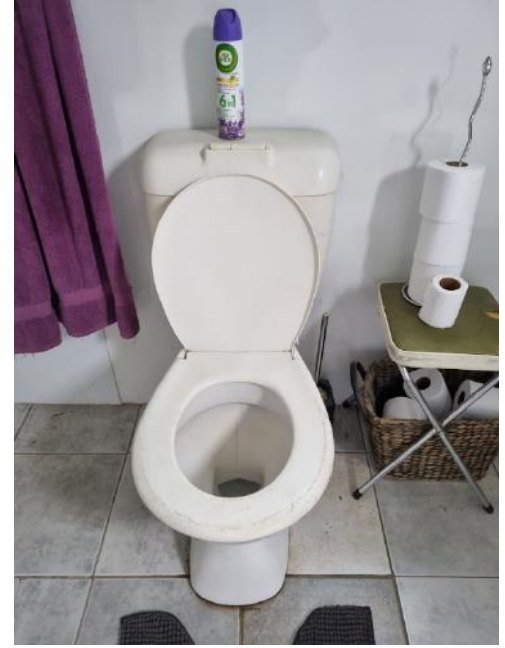
Tiles to floor in bathroom have a few broken that require replacing

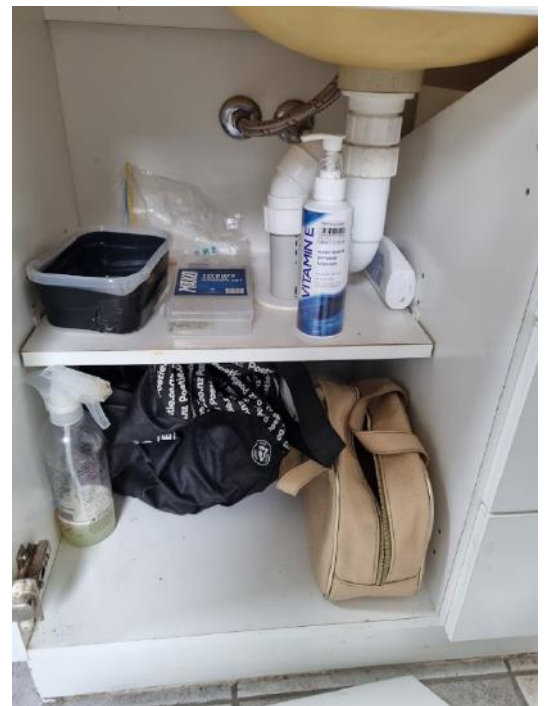
Vanity door in bathroom needs repair

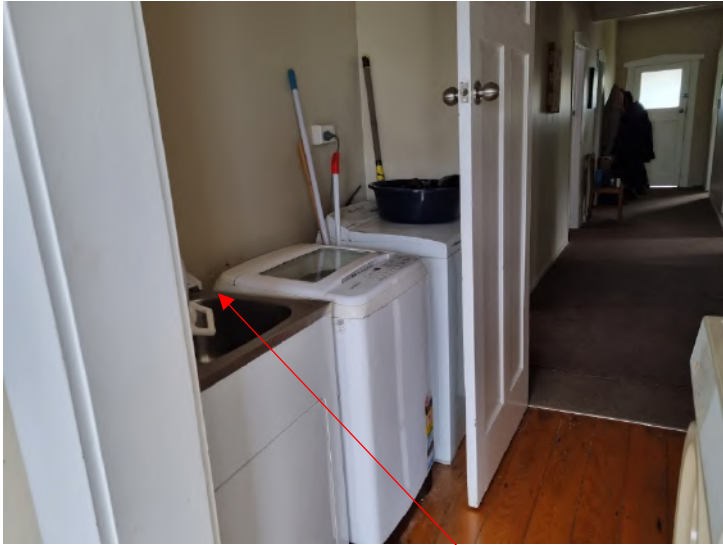
## Laundry and back porch area

Mould is present behind washing machine – further investigation is required

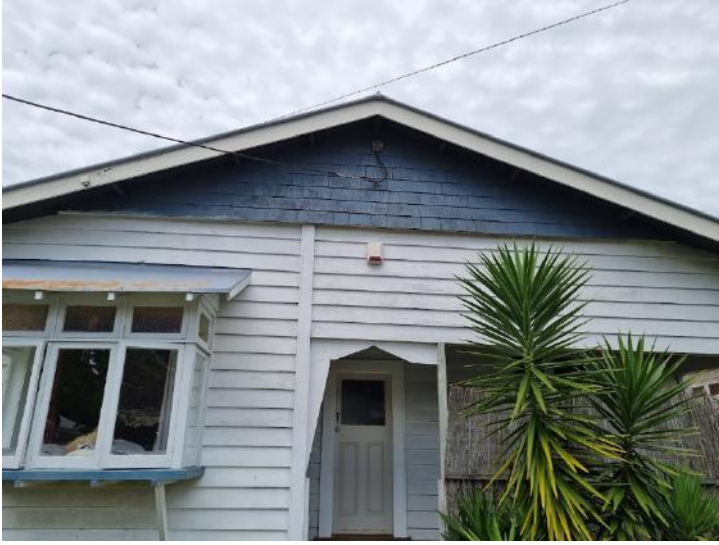
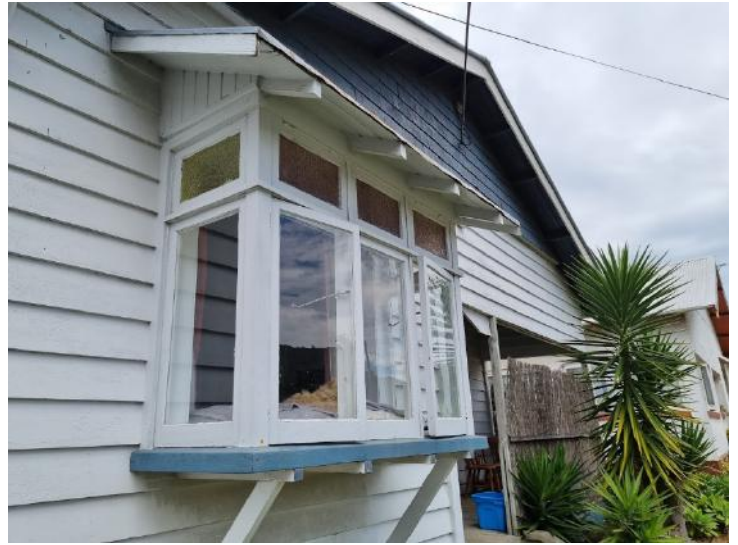
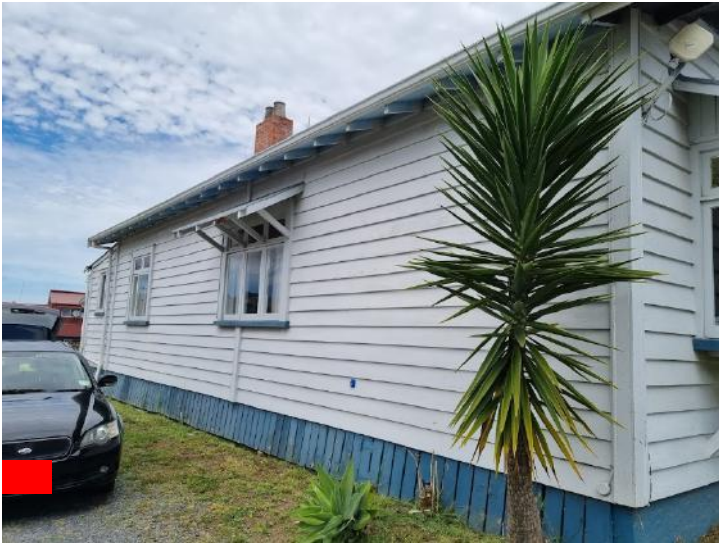
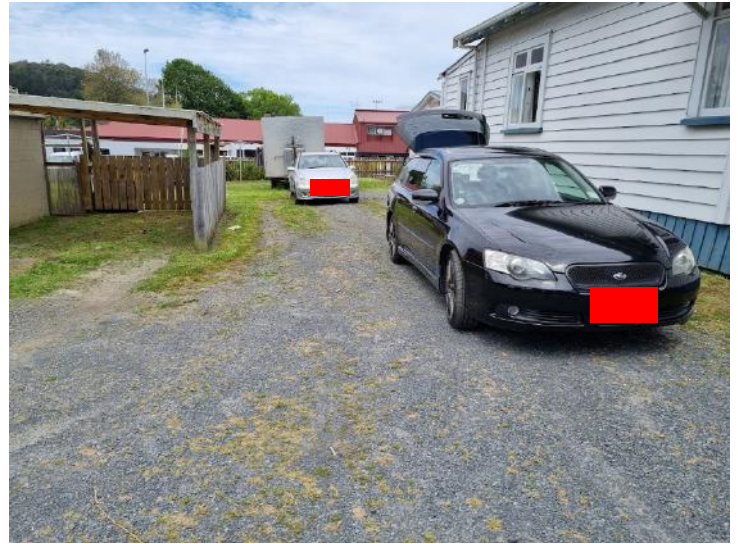
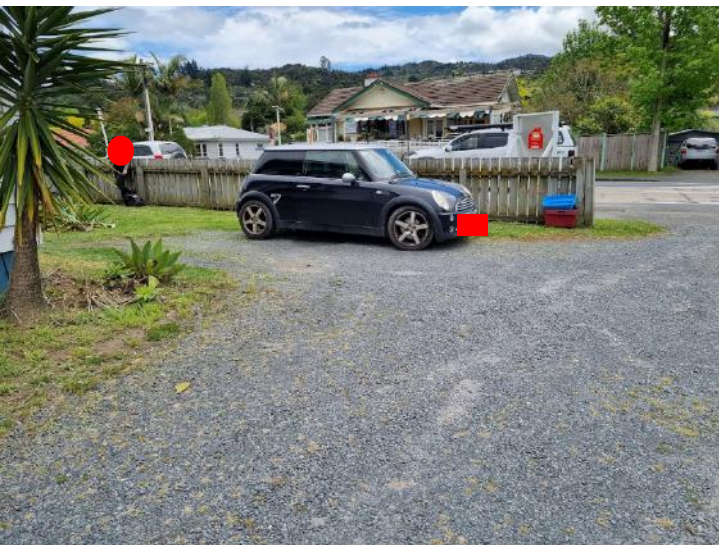
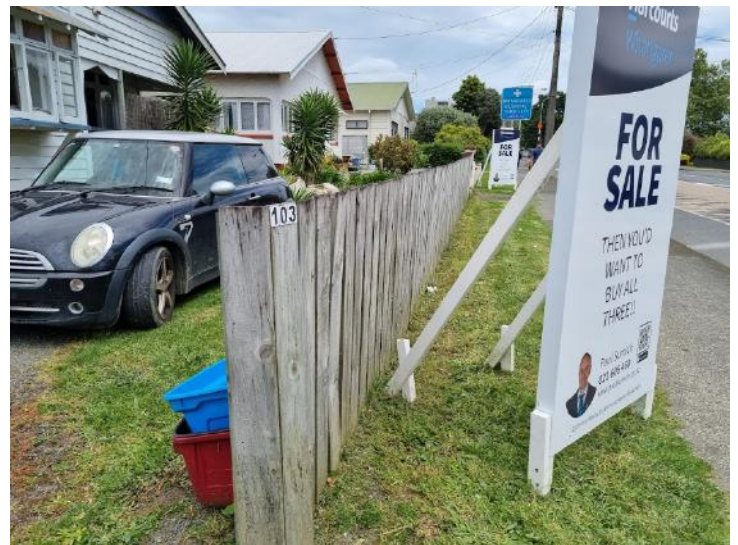
Dwelling front outside and driveway

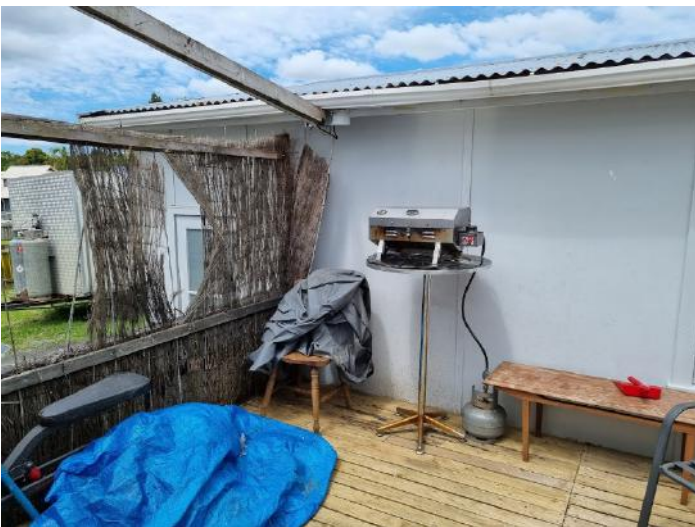
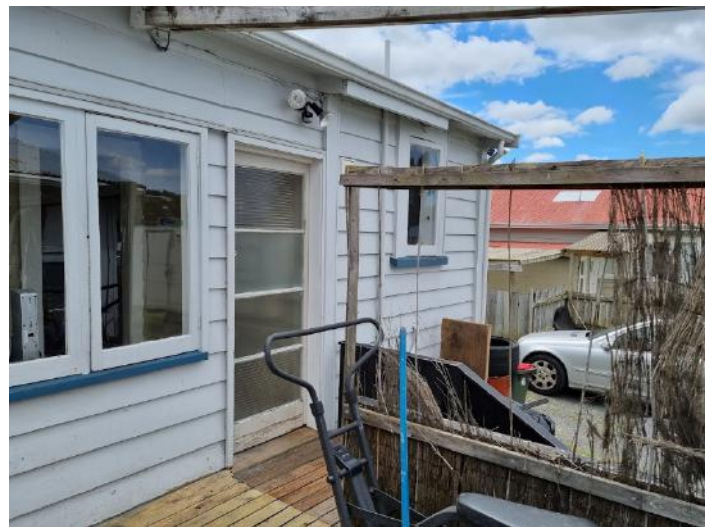
Could not access under the decking

Rear decking boards need replacing – no access to view the deck frame but this is up and down, this can be repaired once decking is lifted.

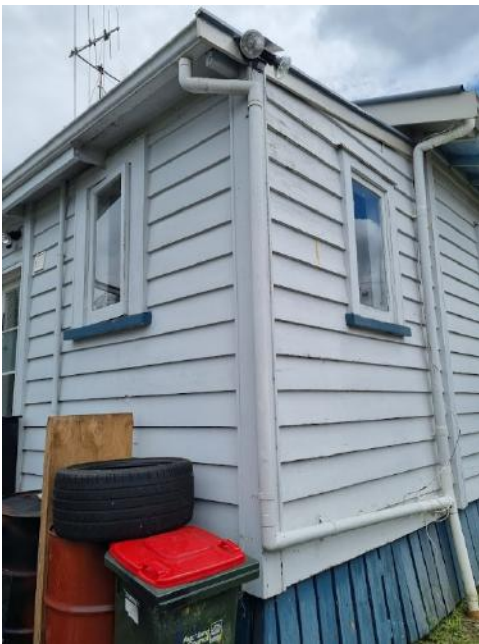
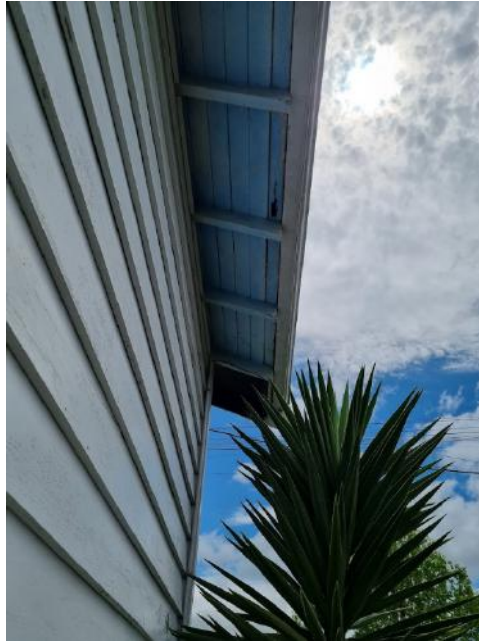
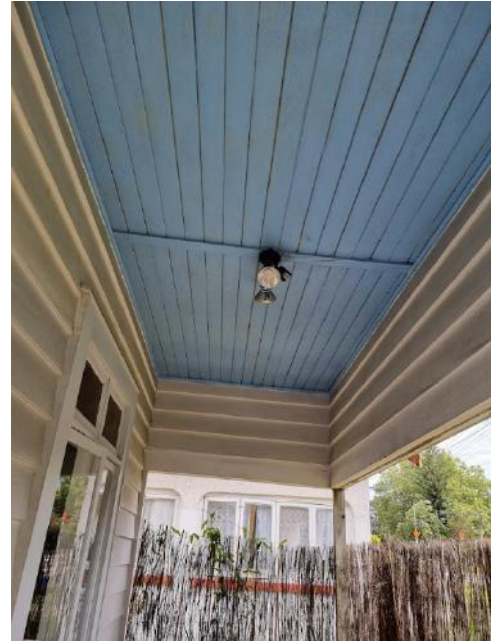
Signs of deterioration to the tongue and groove soffit boards, the timber cladding, the window facings, and corner facings

Exterior cladding would benefit with a complete paint

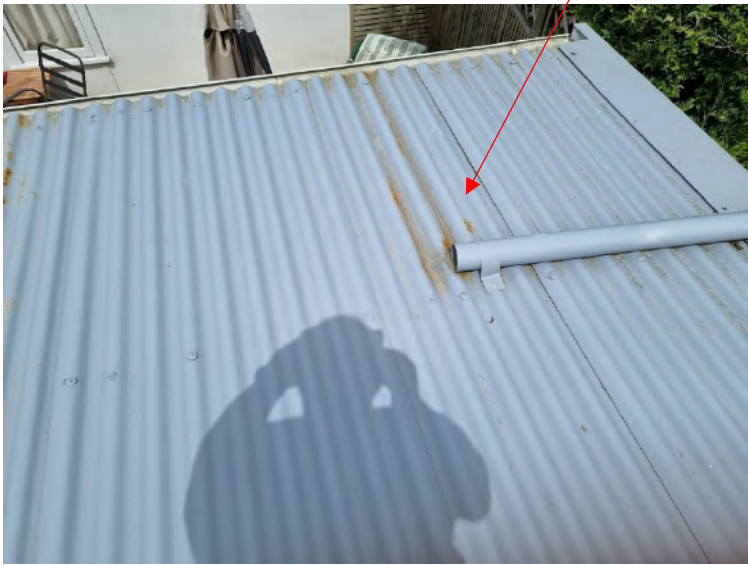
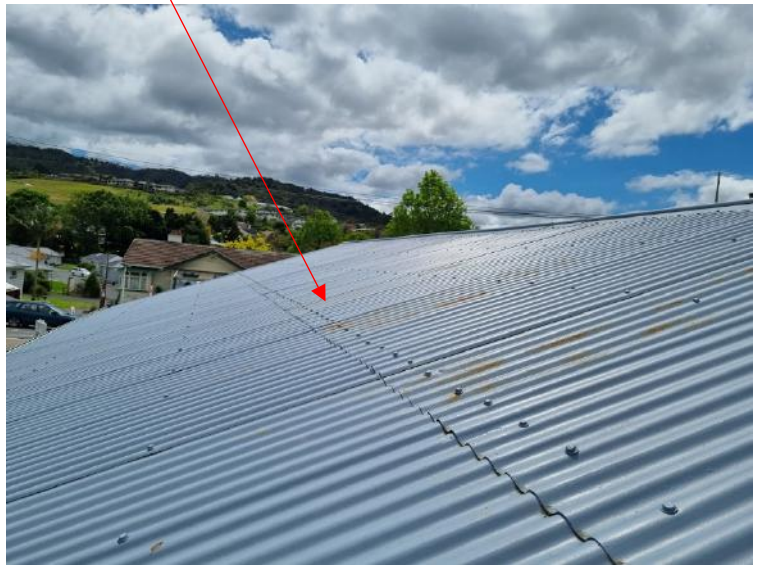
Roof is due for a replacement as it is showing signs of rust and deterioration
