# Building Inspection Report

Client: Paul Sumich  
Location: 105 Maunu Road, Woodhill  
Whangarei

Inspection Date: 19/10/2021

RE: Building Inspection Report, 105 Maunu Road, Woodhill, Whangarei.

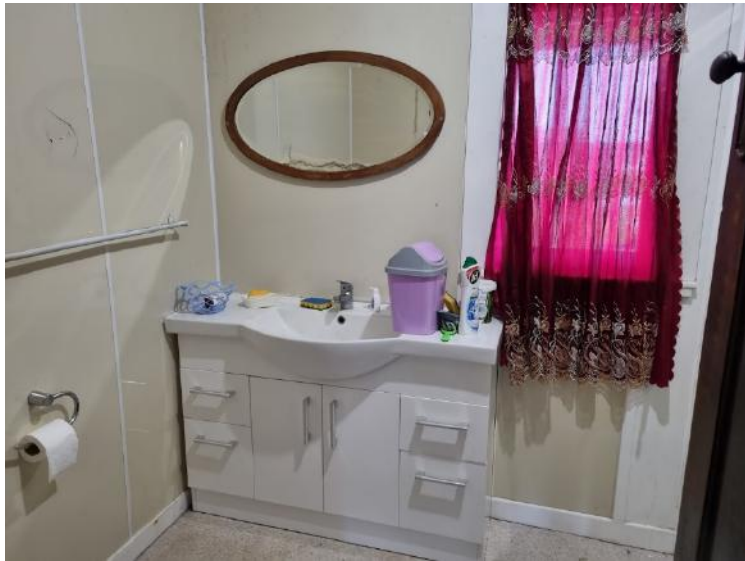
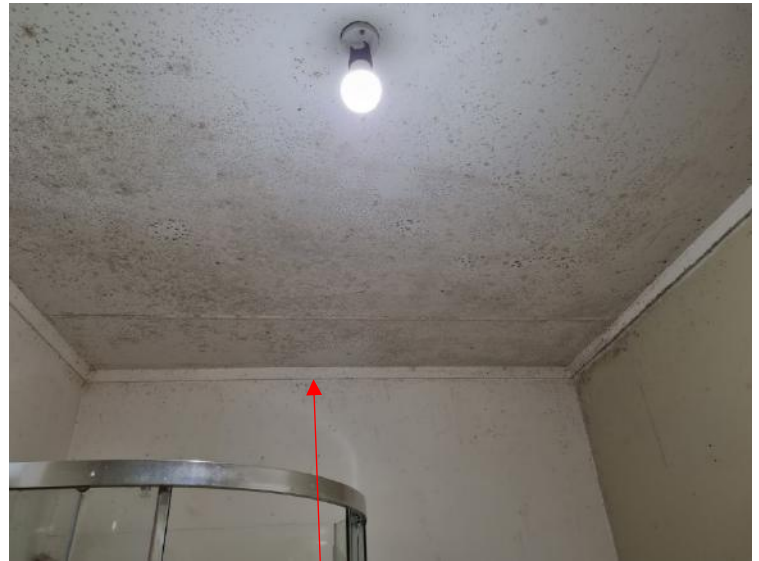
# Bathroom

Bathroom has heavy signs of mould, most likely due to no extractor fan

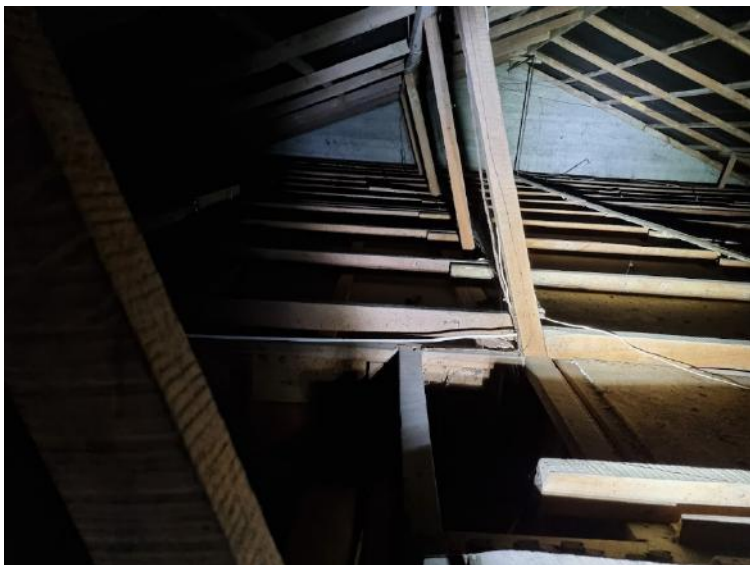
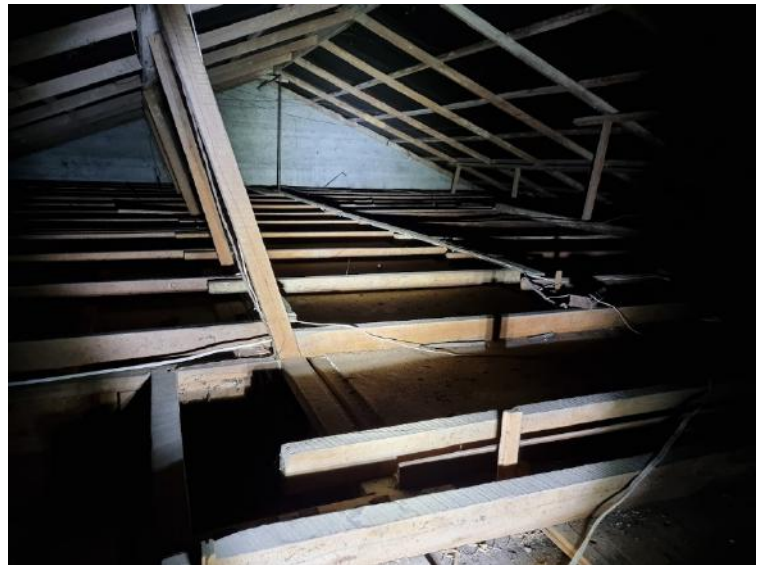
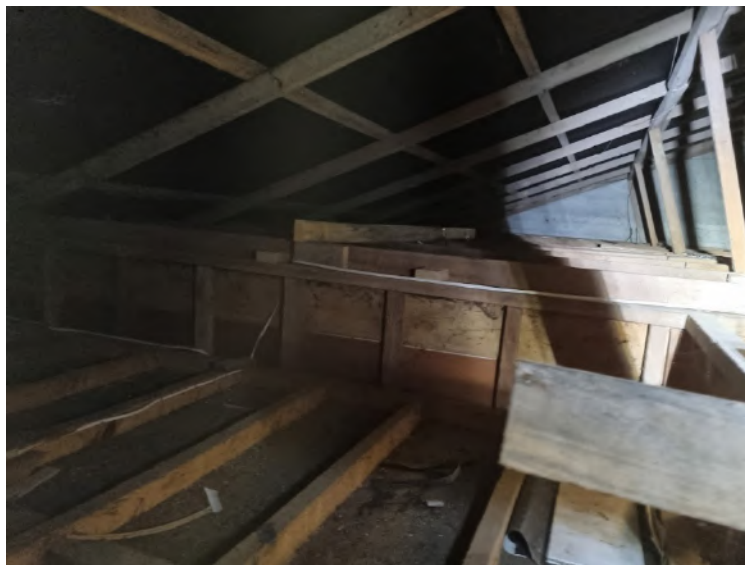
Ceiling is missing insulation

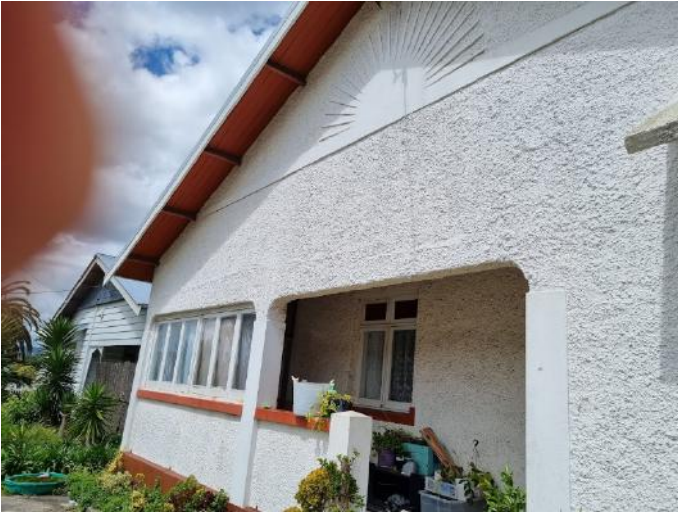
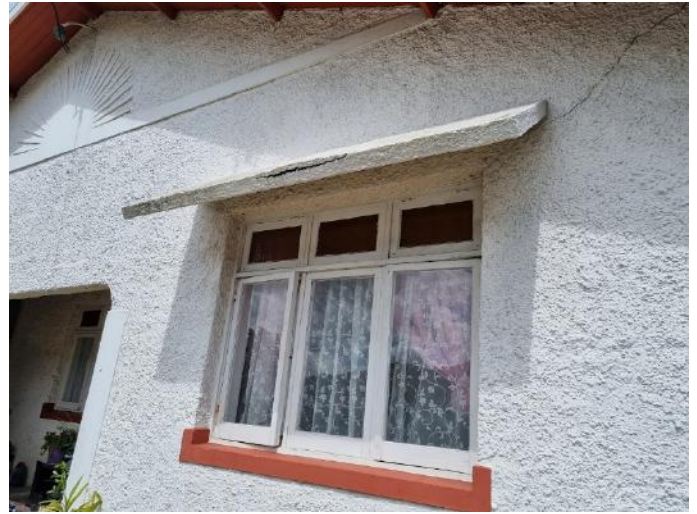
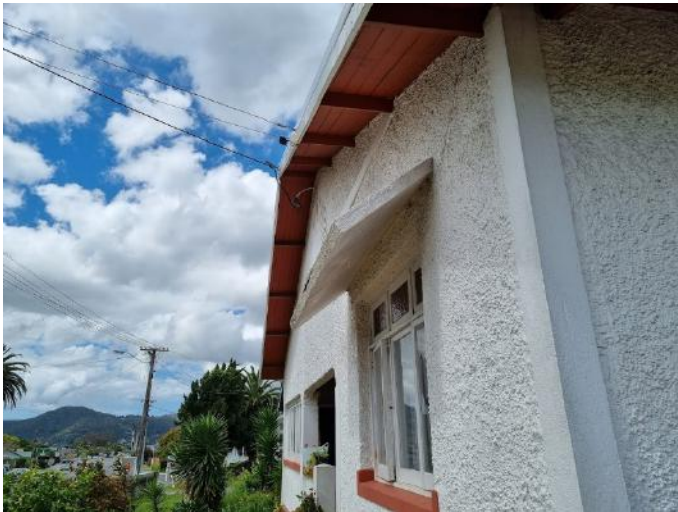
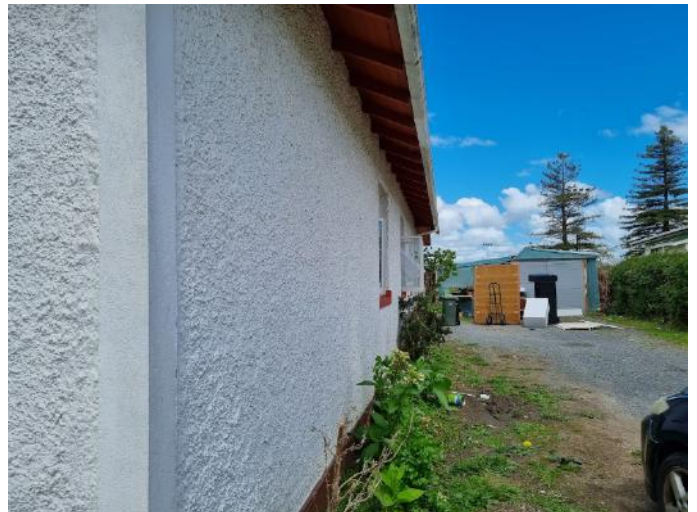
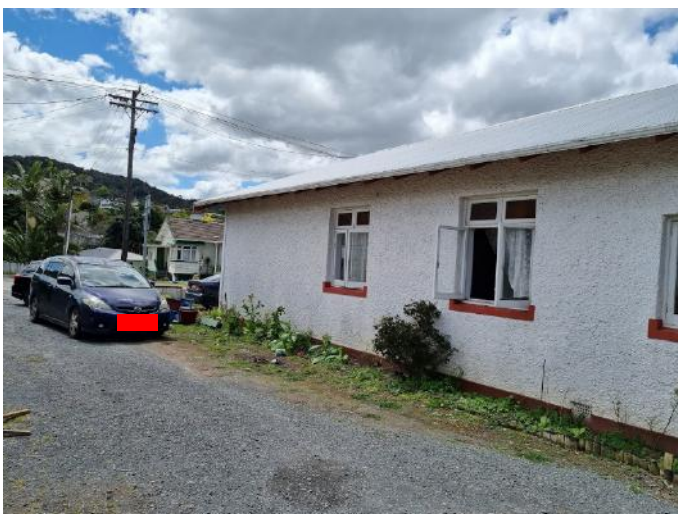
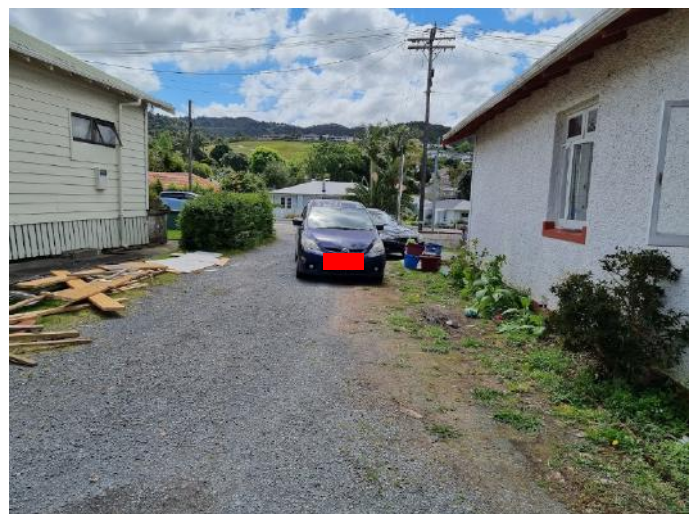
Dwelling front outside and driveway

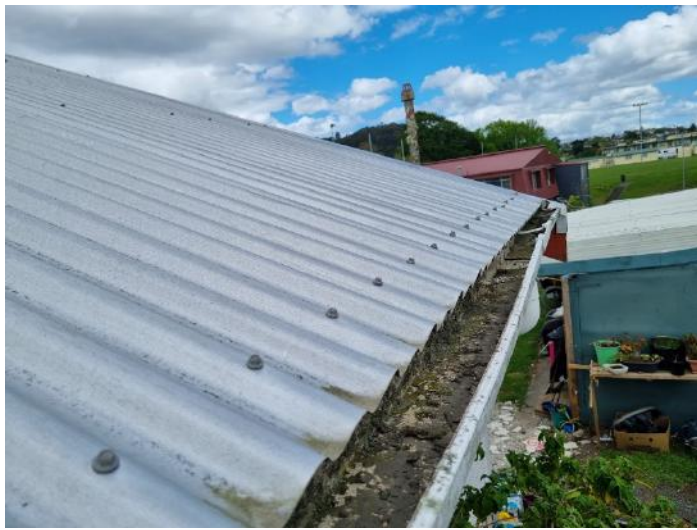
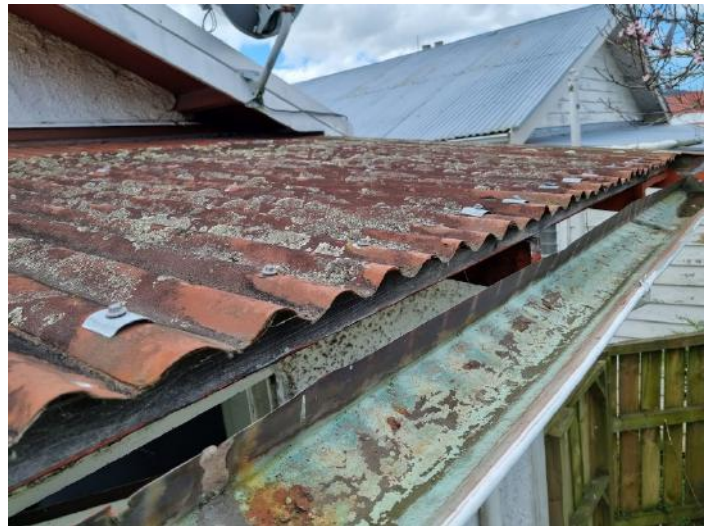
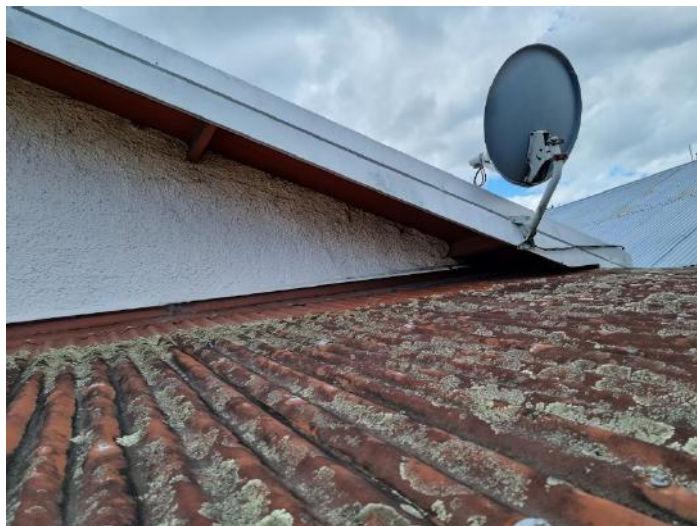
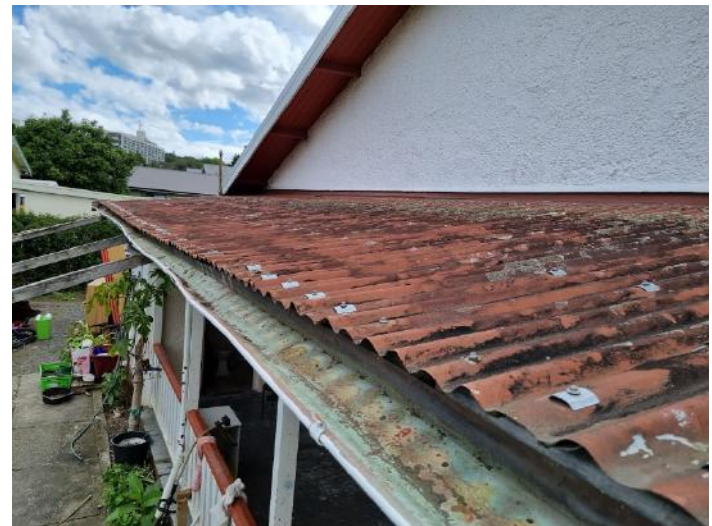
Could only examine the west and south side of the roof
