Building Inspection Report

Client: Paul Sumich
Location: 11 Paranui Valley Road, Tikipunga
Whangarei

Inspection Date: 19/10/21

RE: Building Inspection Report, 11 Paranui Valley Road, Kamo, Whangarei.

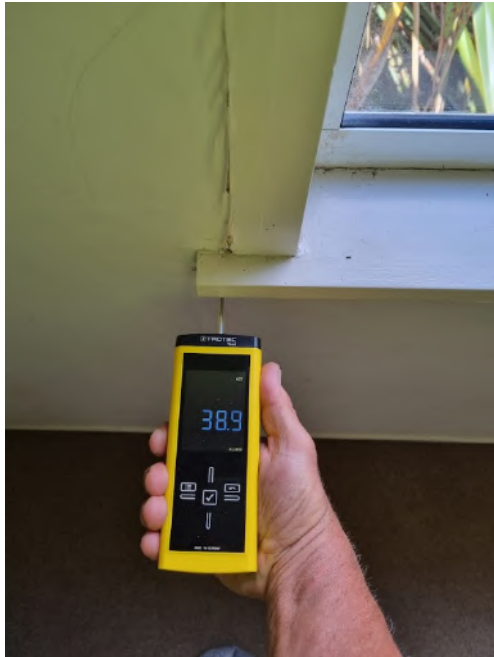
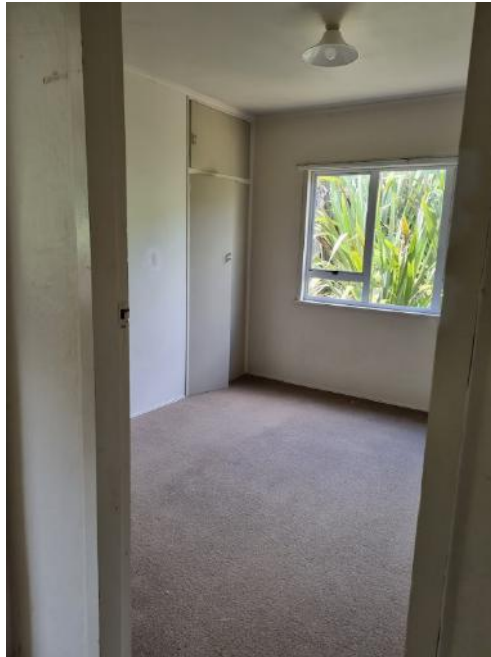
Bedroom 2 door needs plaining – is hard to open with the carpet

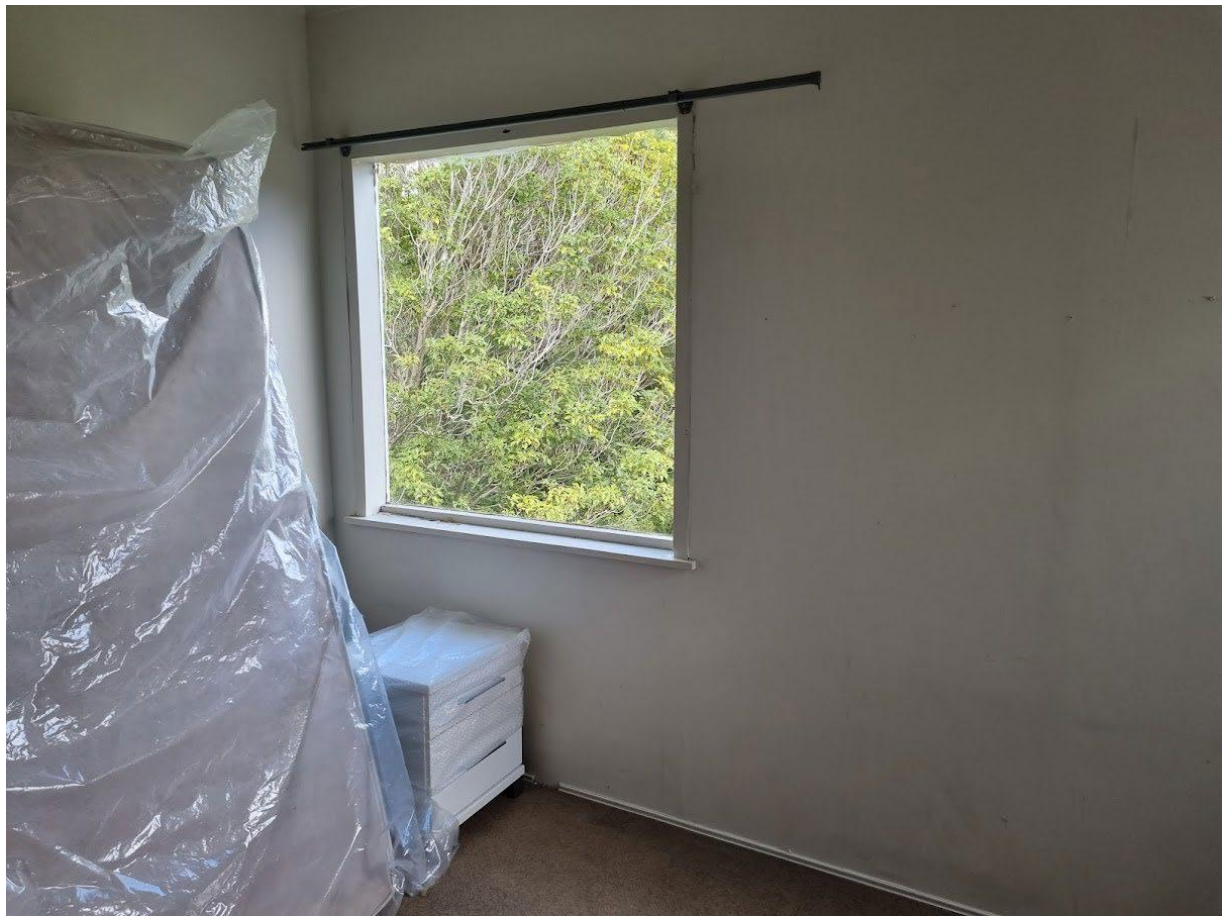
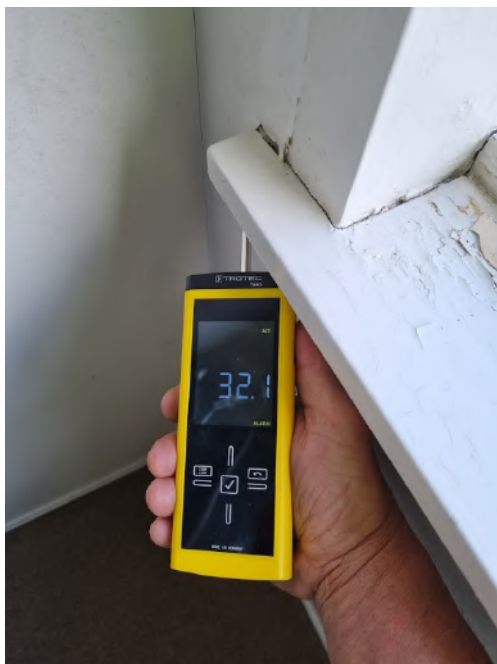
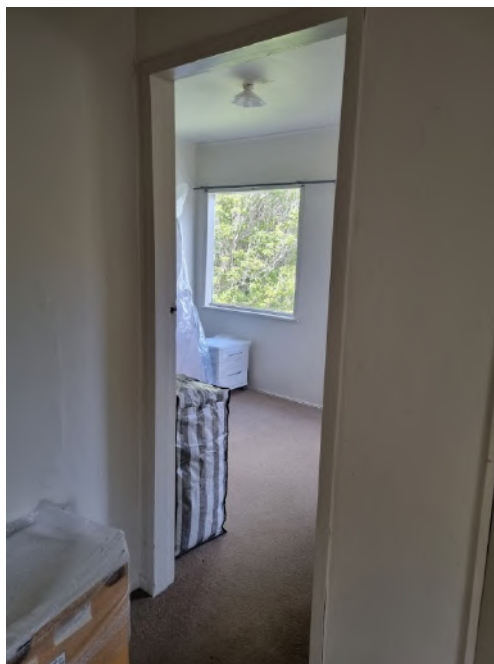
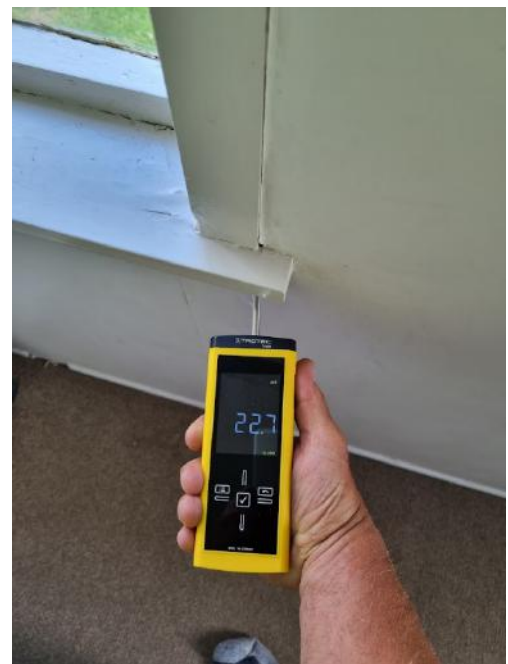
Bedroom 3

- Floor sloping to back door to the kitchen, further investigation is required
- Bedroom 2 door needs shaving – is hard to open with the carpet
- Ceiling water damage observed to bedroom 3
- Shower door is missing
- Water ingress visible in the past with the shower
- Signs of dampness to ceiling in bathroom
- Water damage to vanity cabinetry
- Possible signs of past water ingress in the lounge
- Moisture meter reading higher than 80 shows at risk for wet material, further investigation is required
- Ceiling water damage to laundry
- New insulation to only part of the ceiling as very narrow and they possible couldn't get the rest so the original insulation is still installed in places
- Typical sign of the purlins damage due to water ingress- Re Roof Required
- Requires new spouting

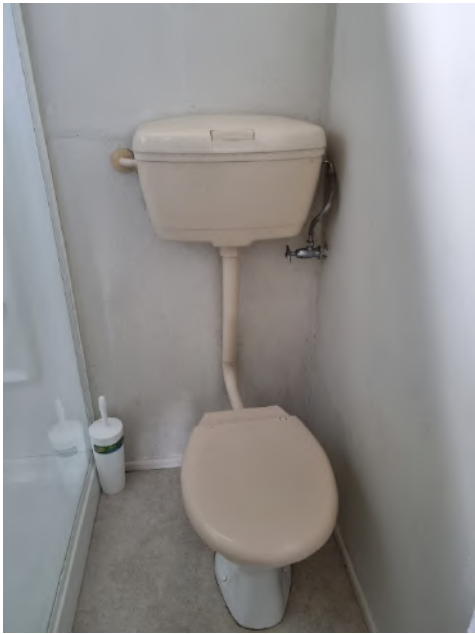
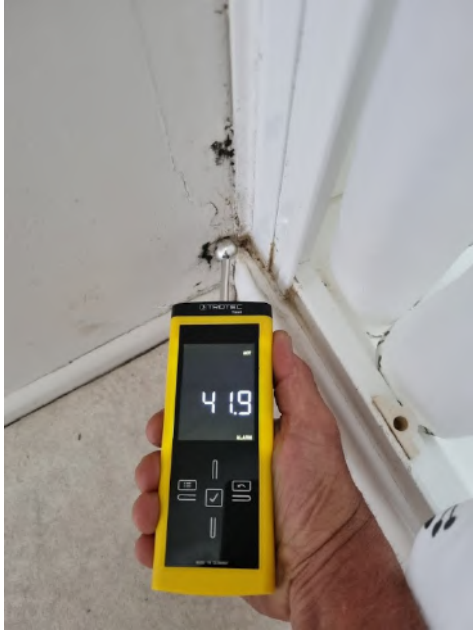
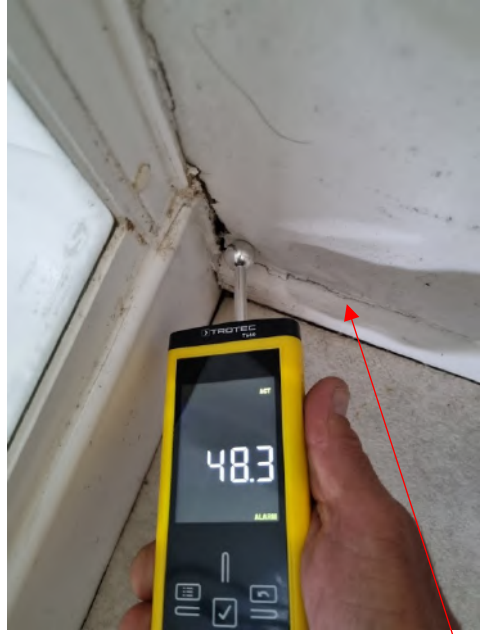
Water ingress visible in the past with the shower

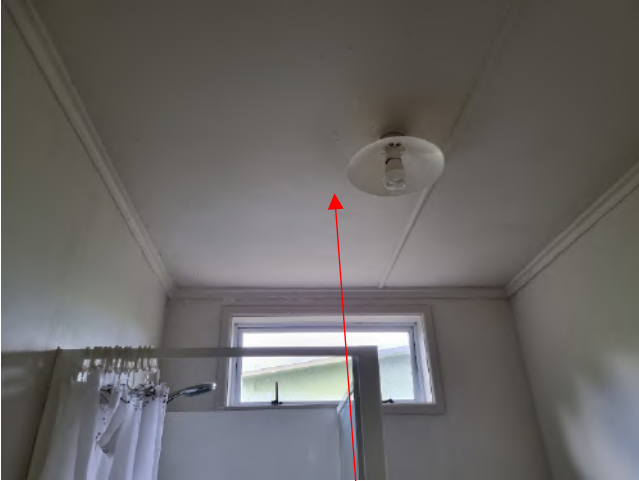
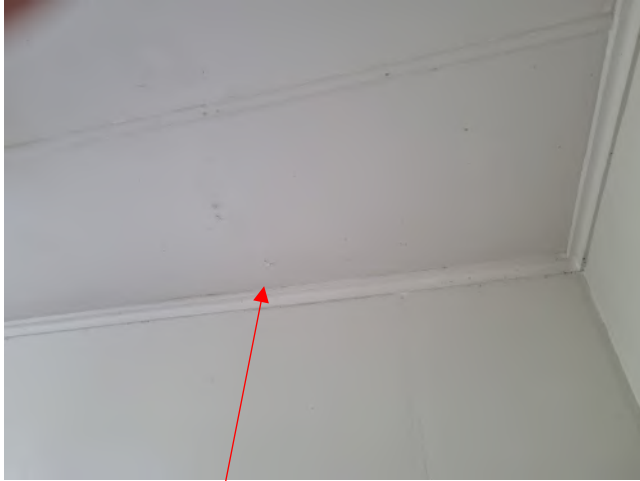
Signs of dampness to ceiling in bathroom

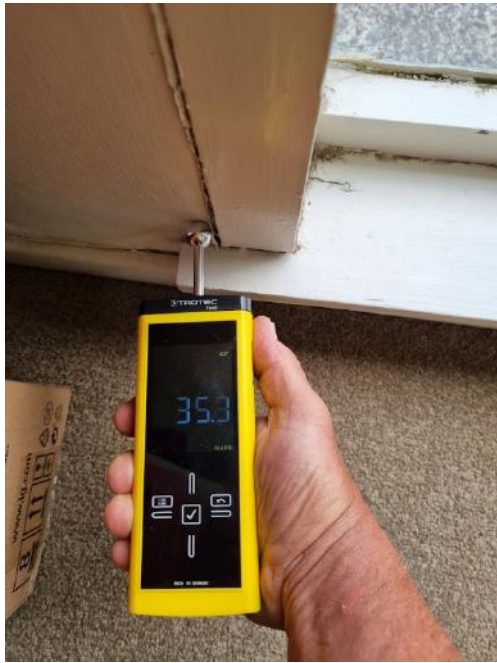
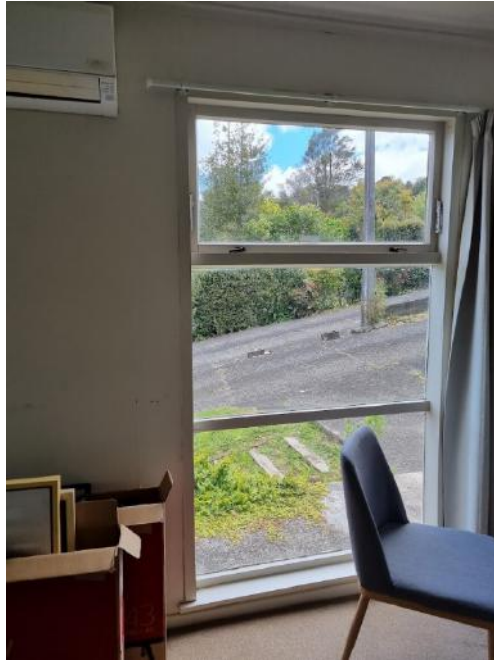
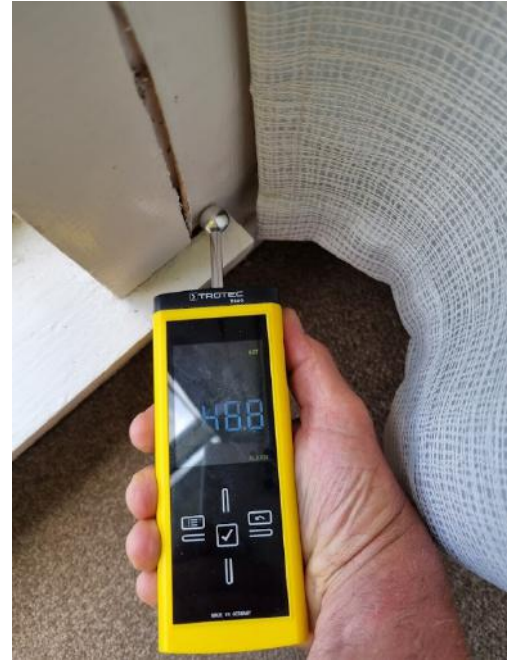
Possible signs of past water ingress in the lounge

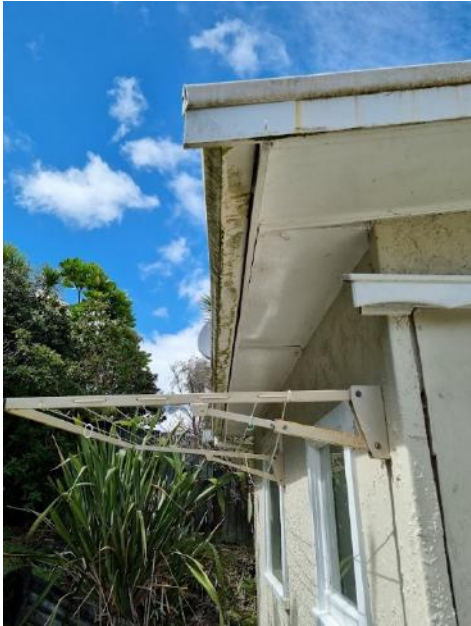
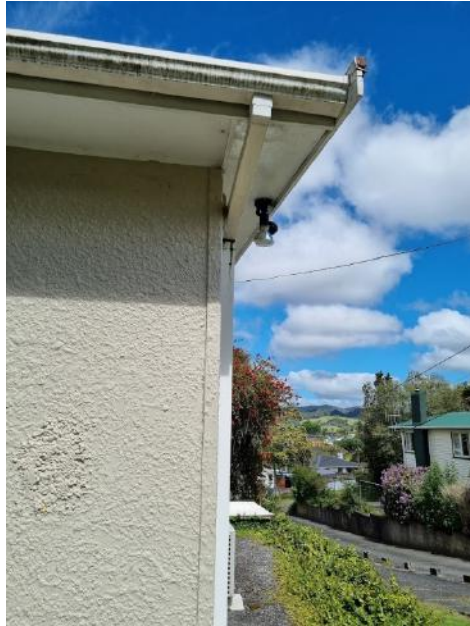
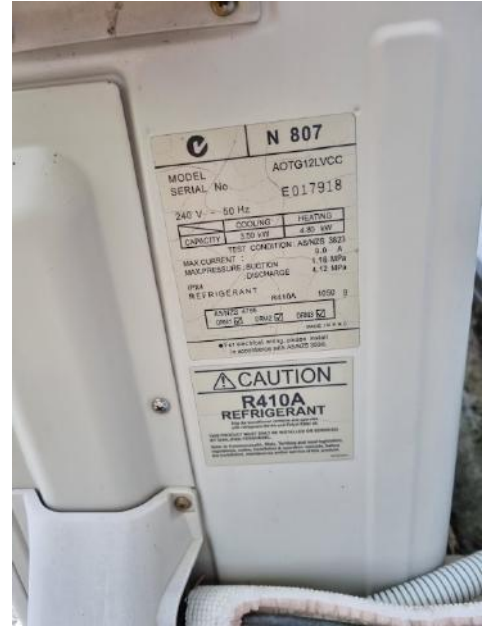
Requires new spouting

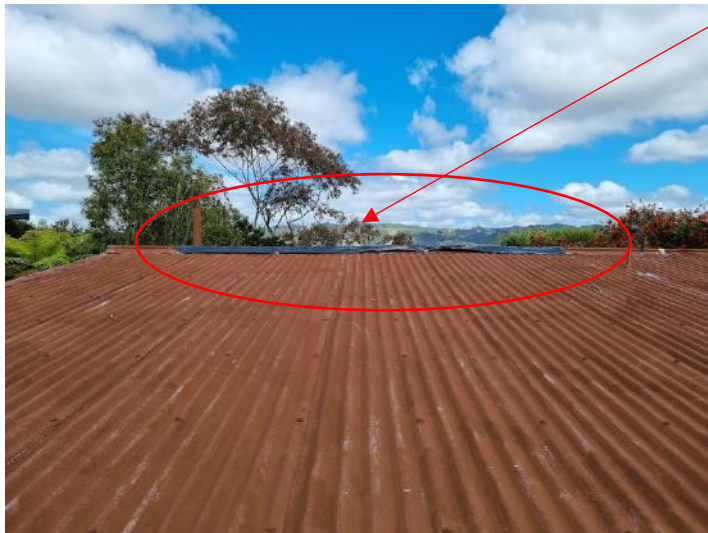
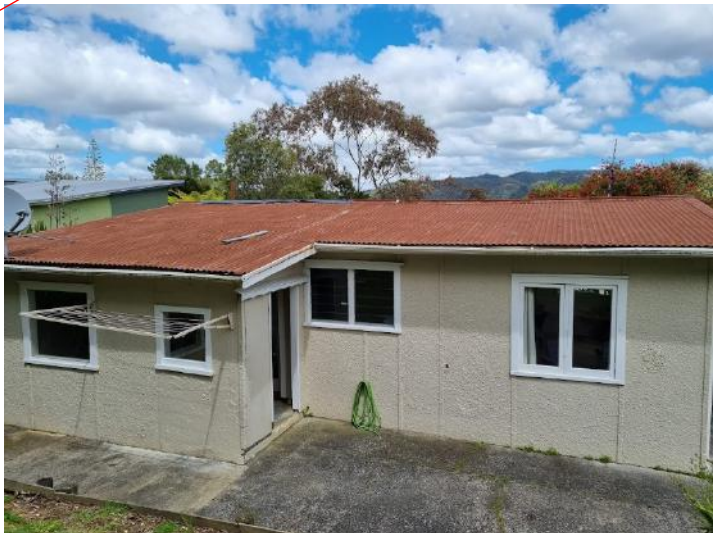
Requires new roofing iron and ridge capping is rotten

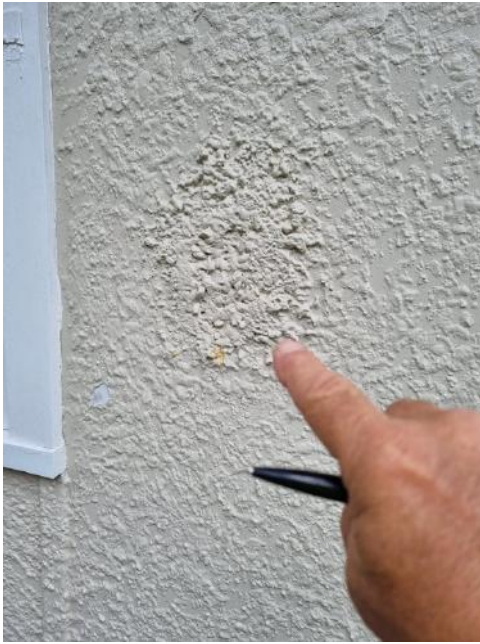
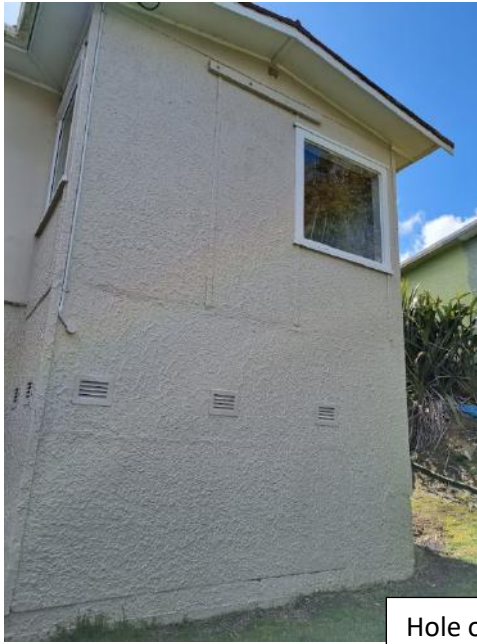
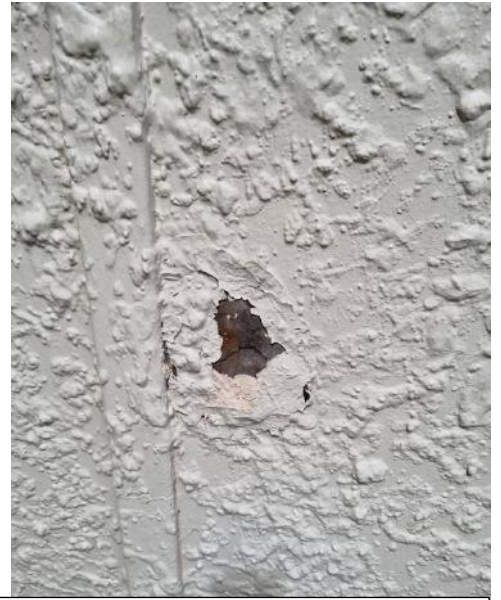
Hole on cladding vulnerable to water ingress

Requires a cladding plasterer specialist to check over the cladding – requires/recommend a reclad as there are holes allowing water ingress, Asbestos warning with cladding as there is fibrolite present, take precaution and use PPE.
