Building Inspection Report

Client: Paul Sumich
Location: 11 Pukemiro Road, Kamo
Whangarei

Inspection Date: 21/10/2021

RE: Building Inspection Report, 11 Pukemiro Road, Kamo, Whangarei.

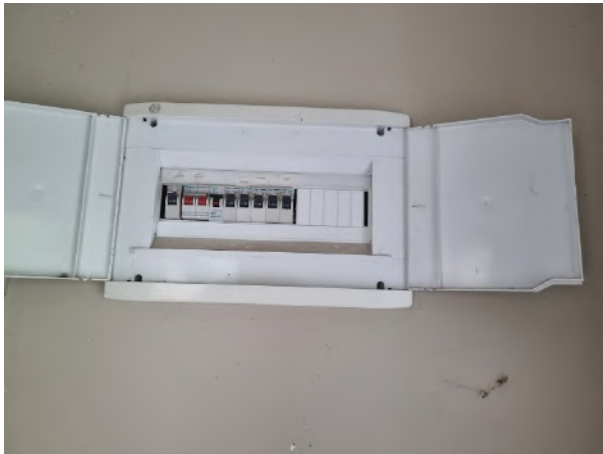
Could not access hot water cylinder for photo evidence

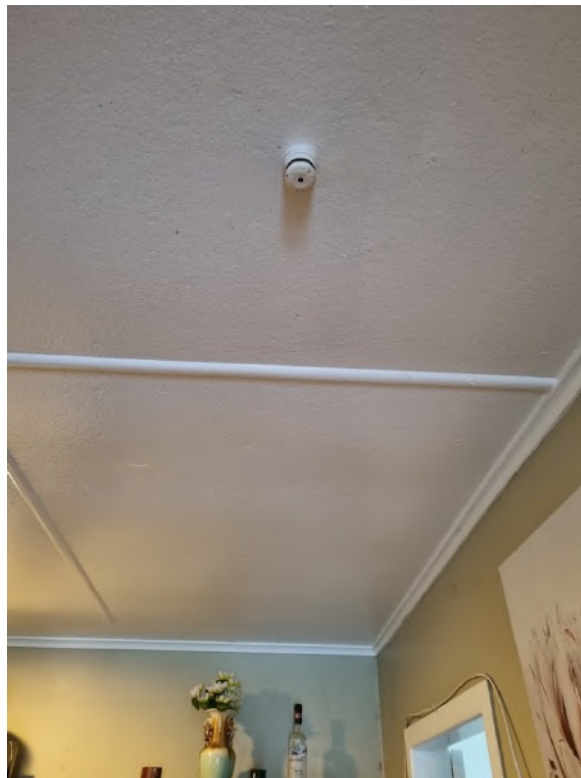
3. Smoke Alarms present

No testing was done on the alarms to check if they are working.

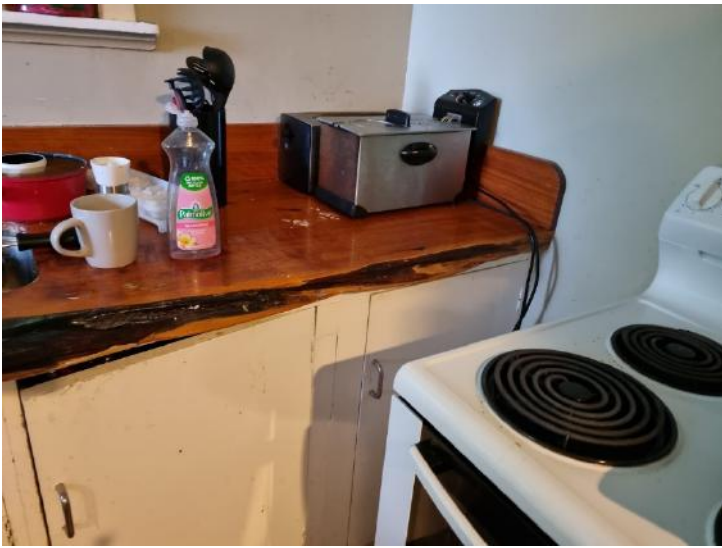
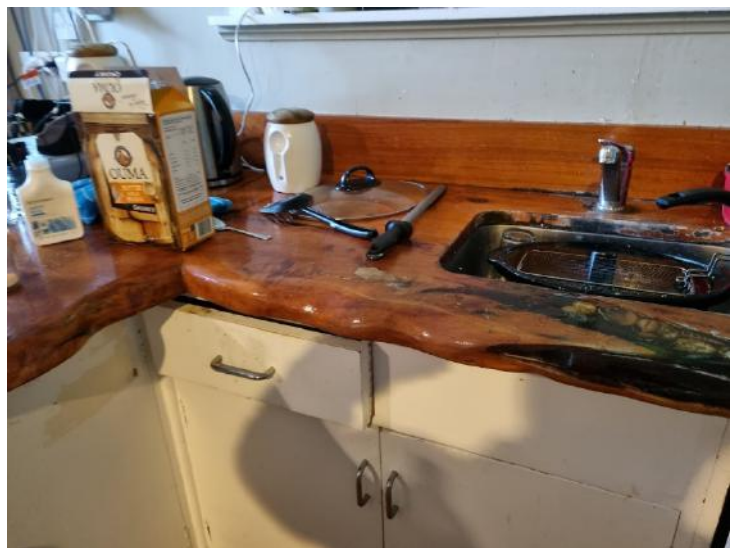
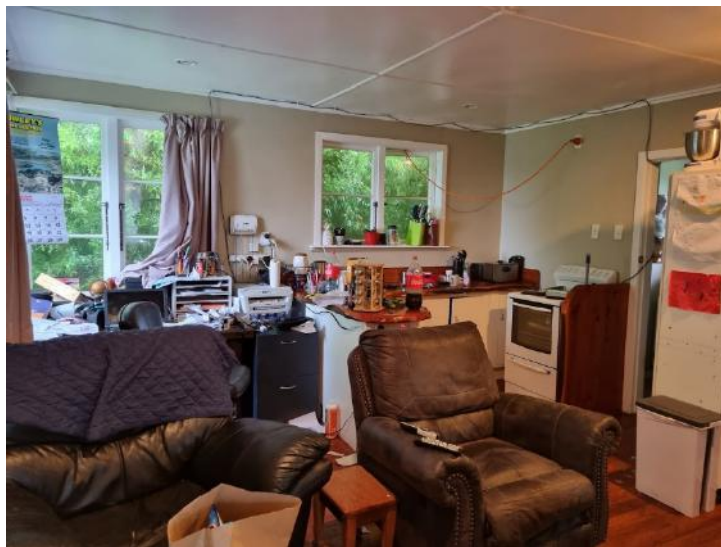
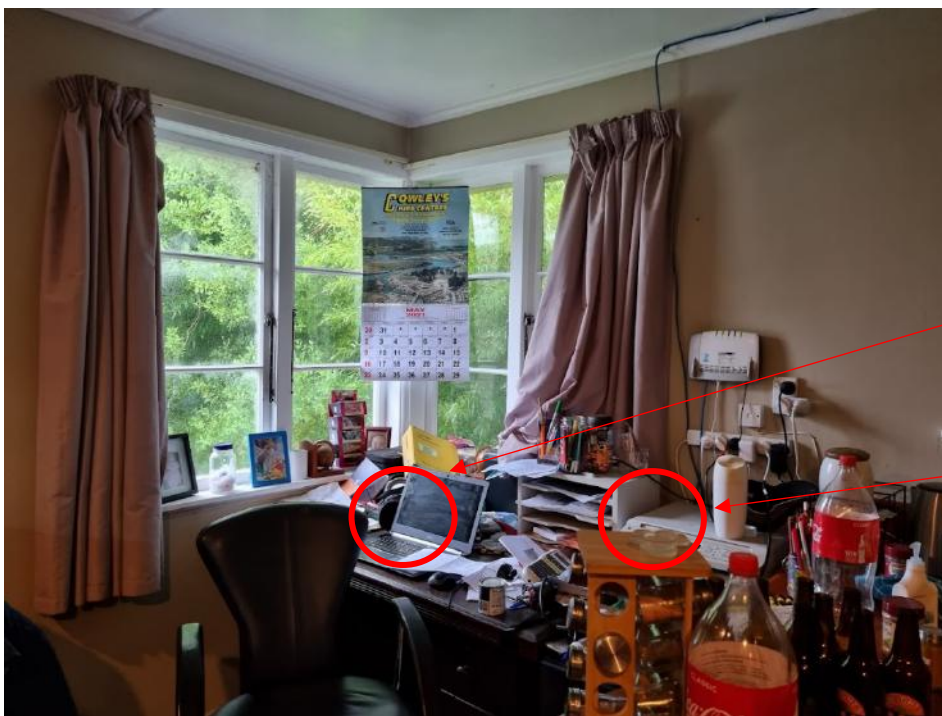
Could not access the middle and right-hand side of the corner window in kitchen/dining/lounge due to furniture blocking the moisture meter reading point

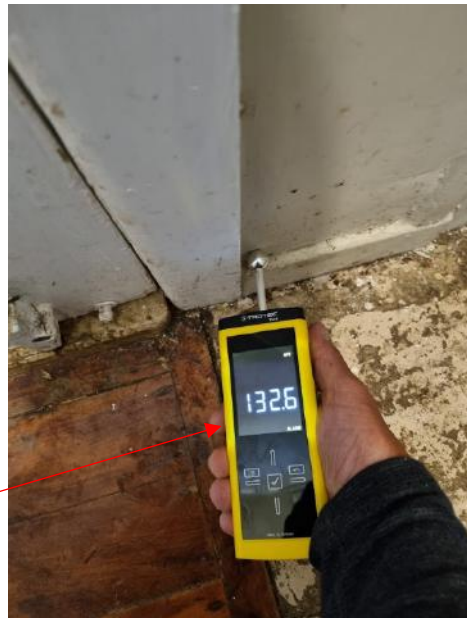
Laundry

Could not access the right-hand side of the laundry window due to appliance blocking the moisture meter reading point

Moisture meter reading is higher than 80, this indicates there is wet materials at risk – further investigation is required

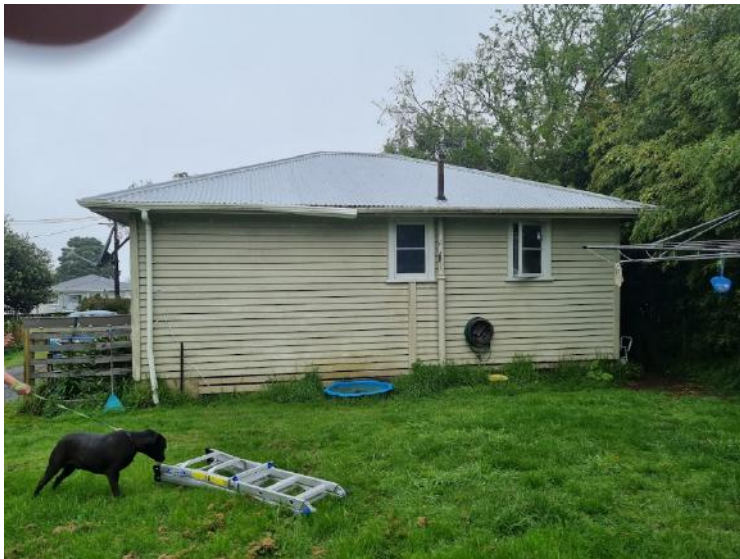
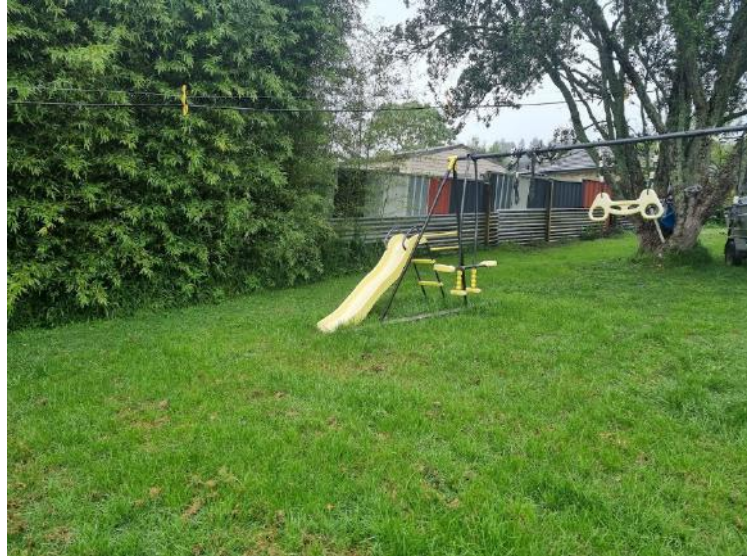
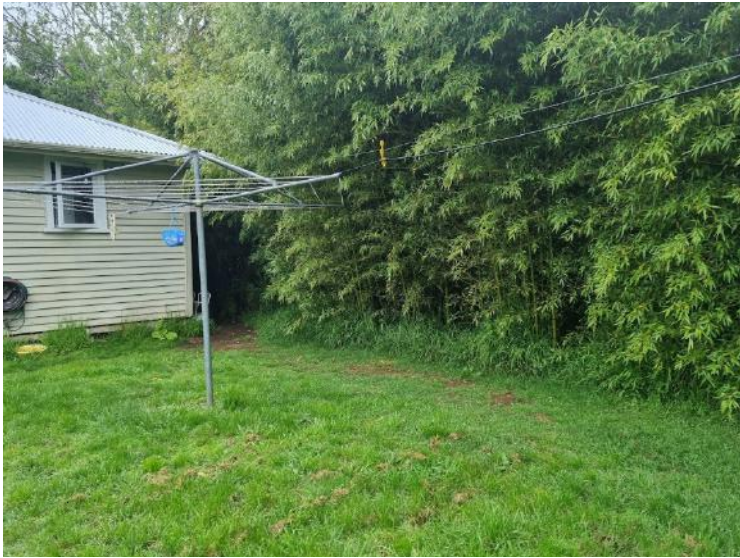
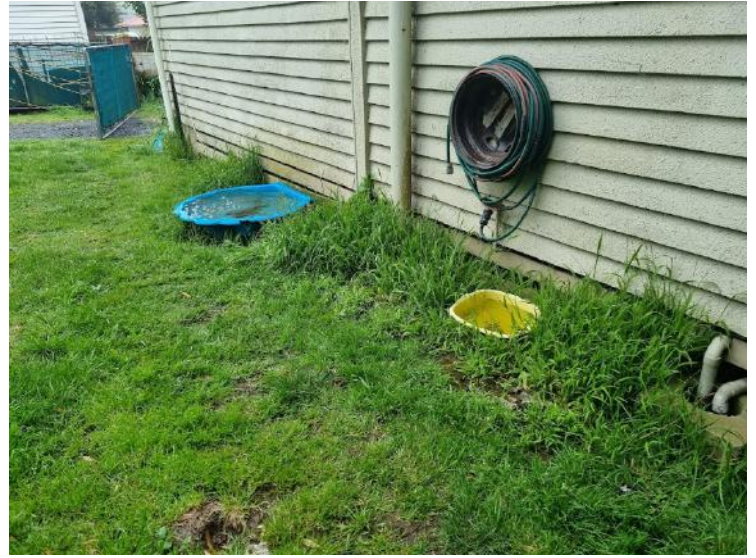
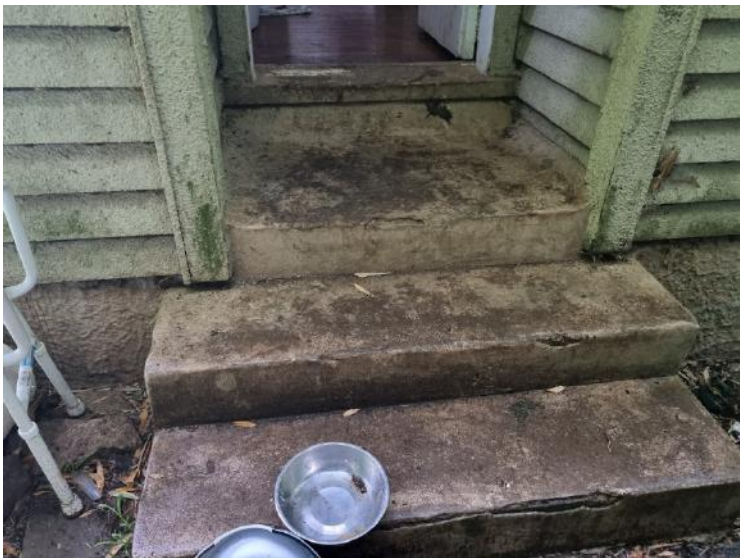
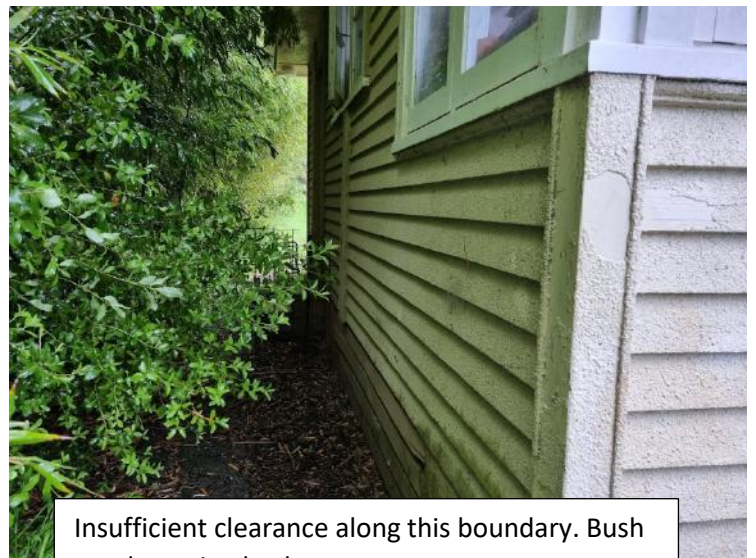
Insufficient clearance along this boundary. Bush needs cutting back.

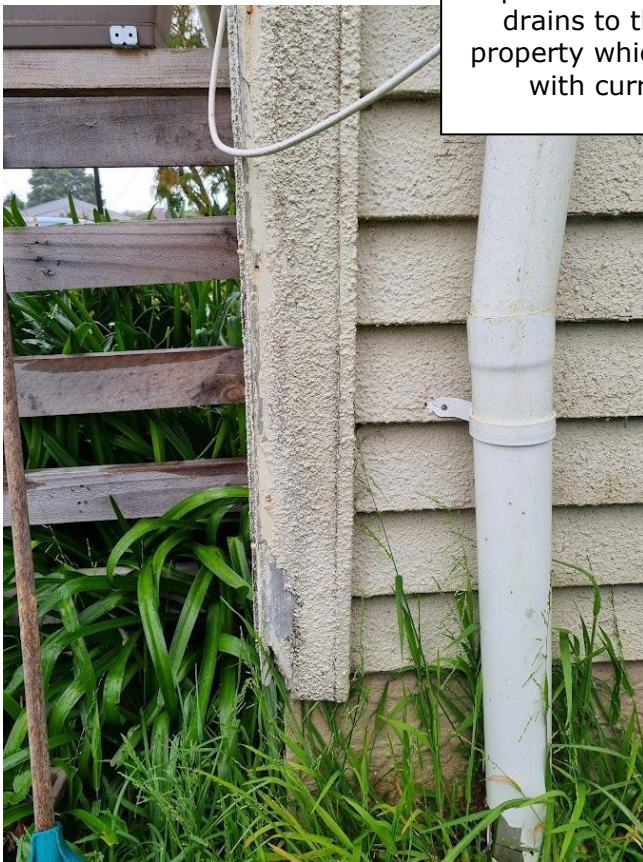
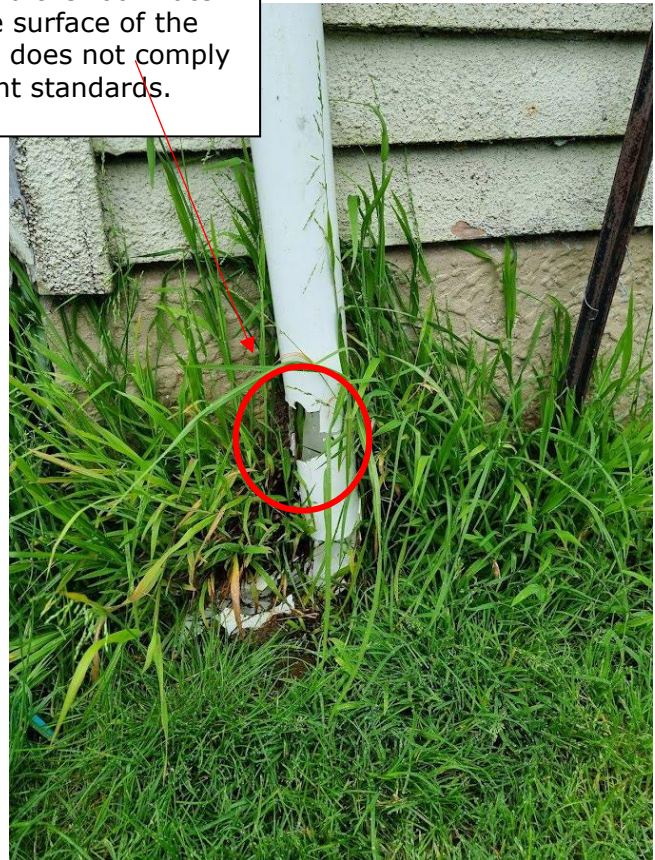
PVC has a hole/tear to rear downpipe, these needs repairing.

Stormwater is not connected to a public line and the roof water drains to the surface of the property which does not comply with current standards.

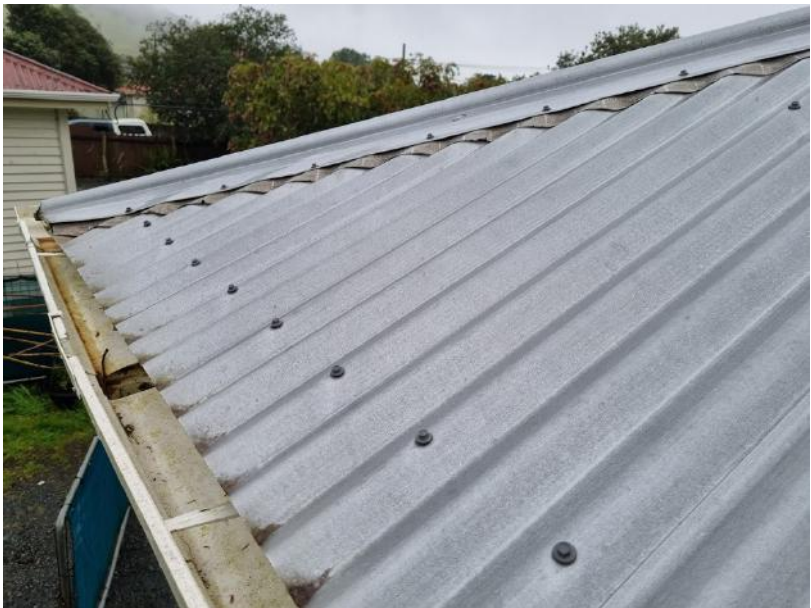
Roofing Iron is in good condition.

Guttering requires repair/general maintenance
