# Building Inspection Report

Client: Paul Sumich  
Location: 7 Pukemiro Road, Kamo  
Whangarei

Inspection Date: 21/10/2021

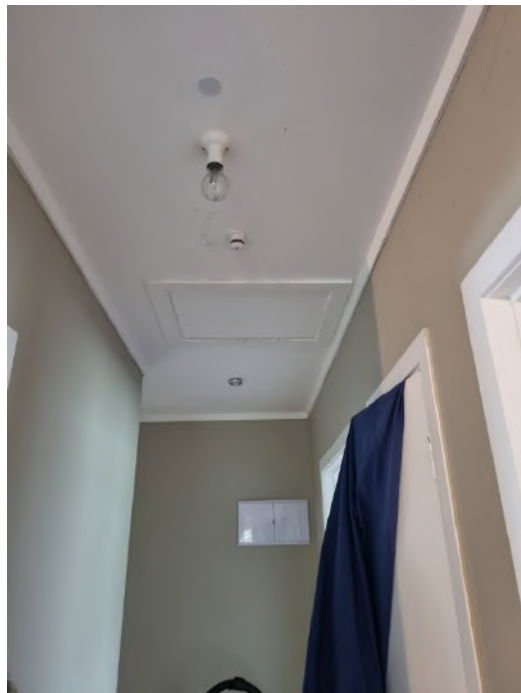
## 3. Smoke Alarms present

No testing was done on the alarms to check if they are working.

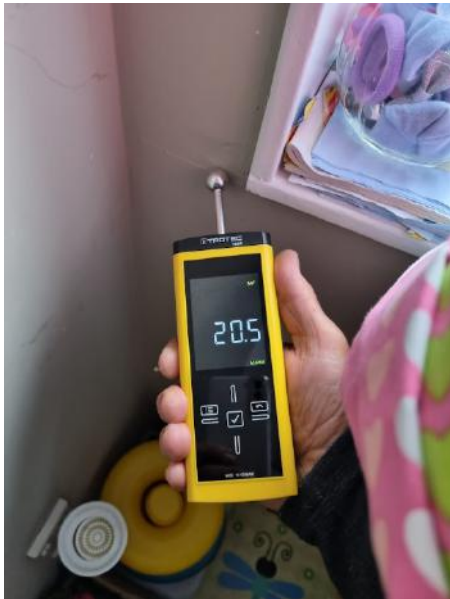
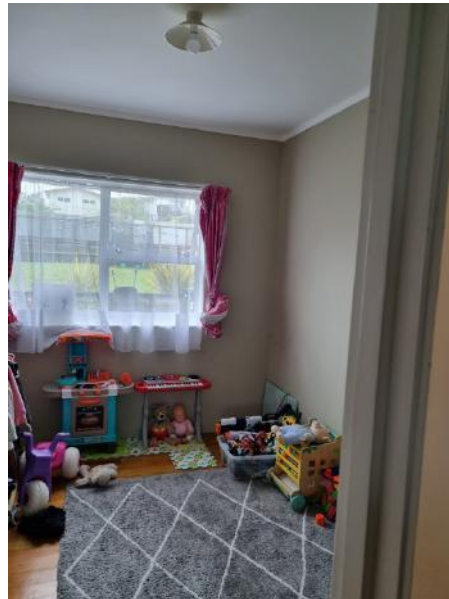
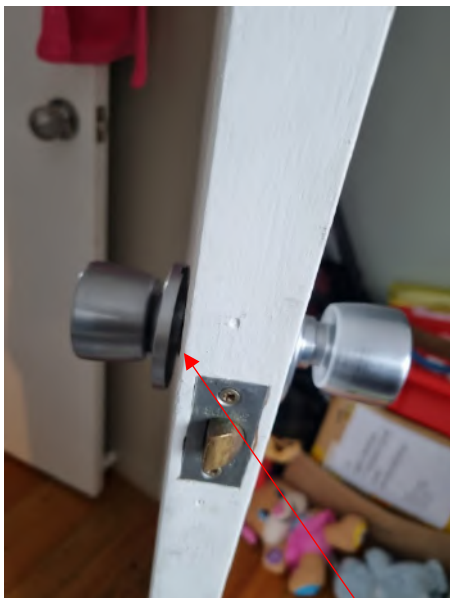
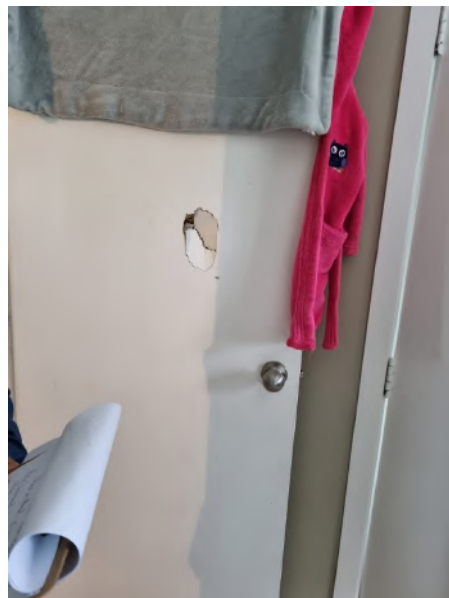
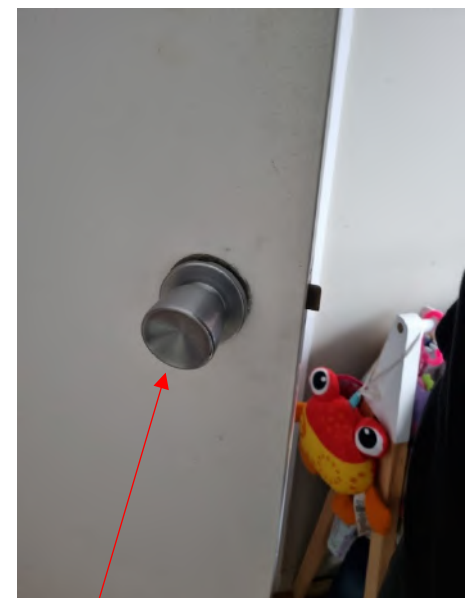
Bedroom 1

Hardware in bedroom 1 needs maintenance

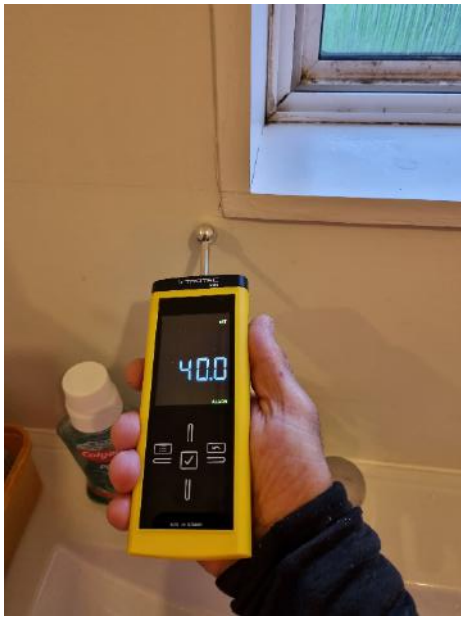
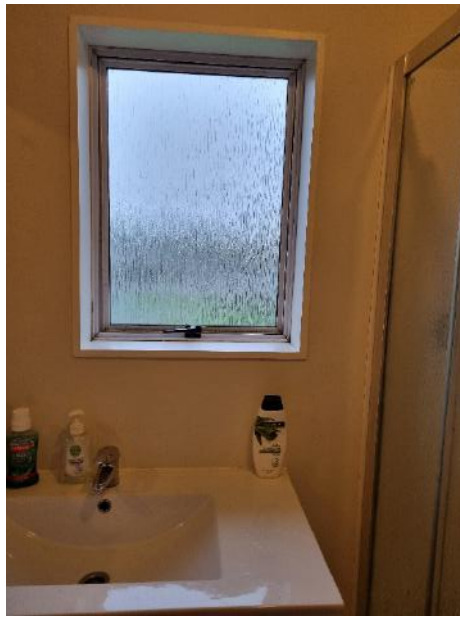
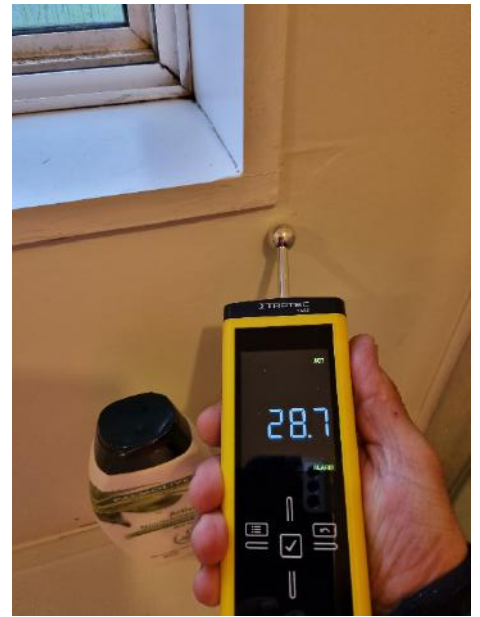
# Bathroom

Mould to ceiling above shower
