Building Inspection Report

Client: Paul Sumich
Location: 9 Pukemiro Road, Kamo
Whangarei

Inspection Date: 21/10/2021

RE: Building Inspection Report, 9 Pukemiro Road, Kamo, Whangarei.

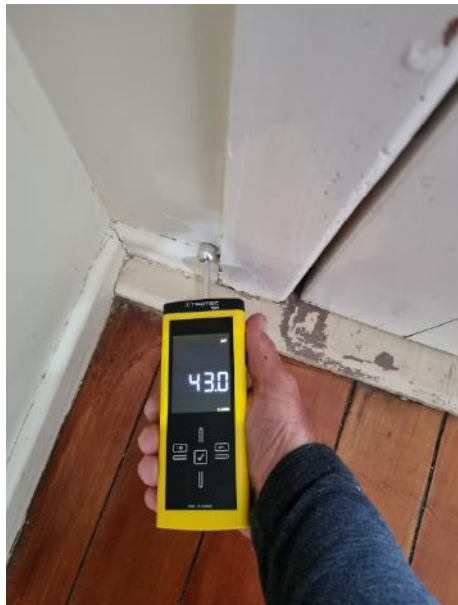
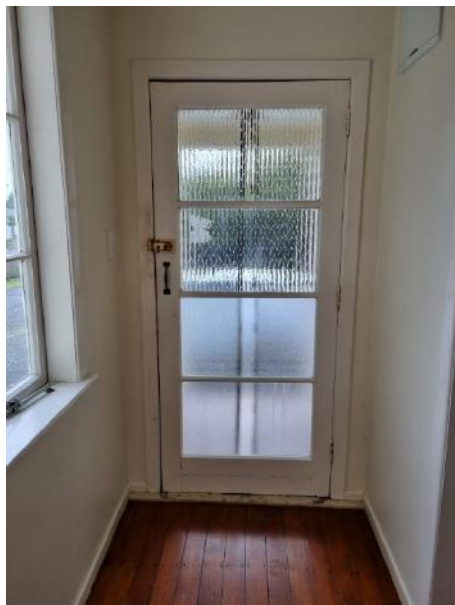
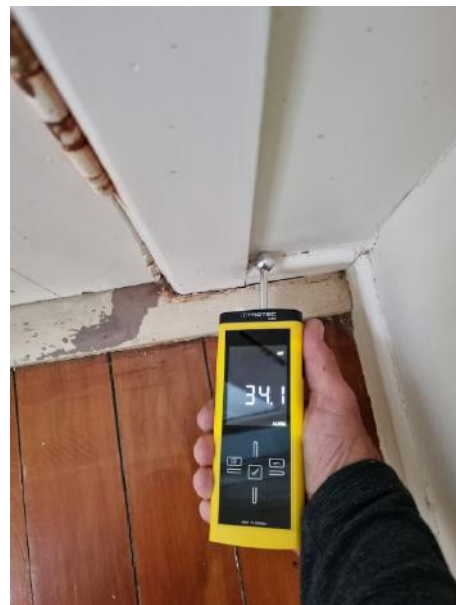
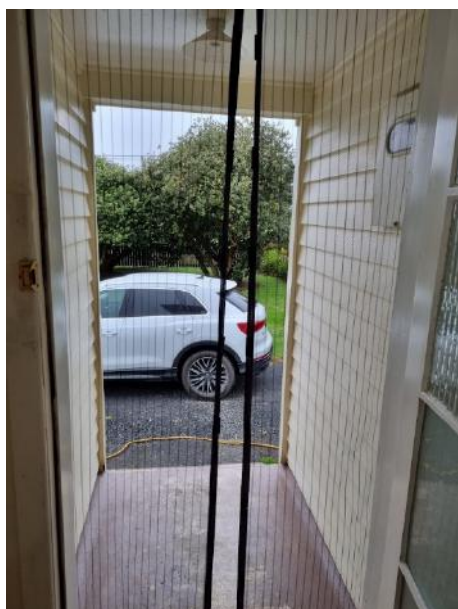
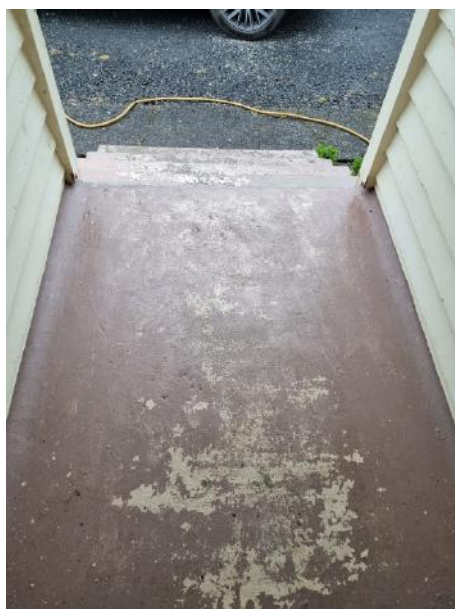
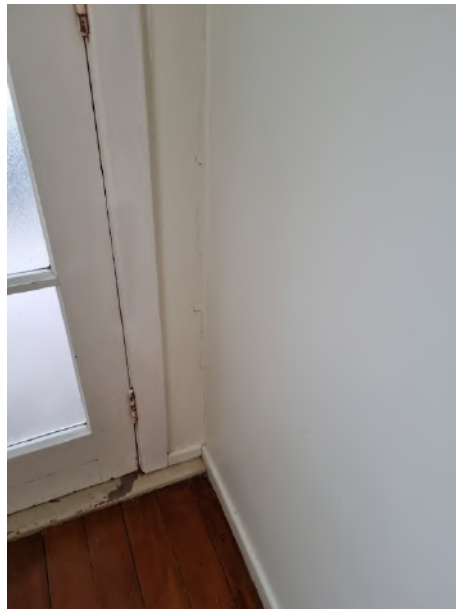
Front Entry

Paint required to front entry door and porch

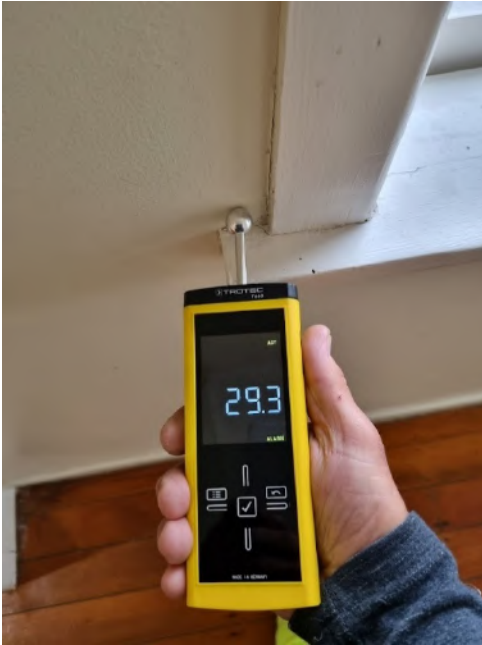
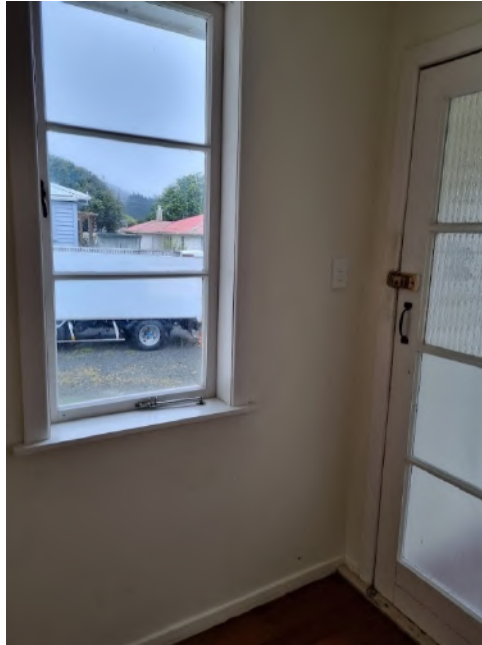
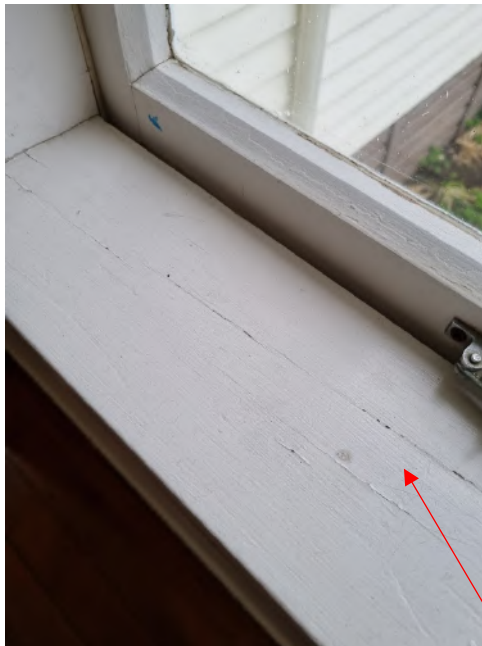
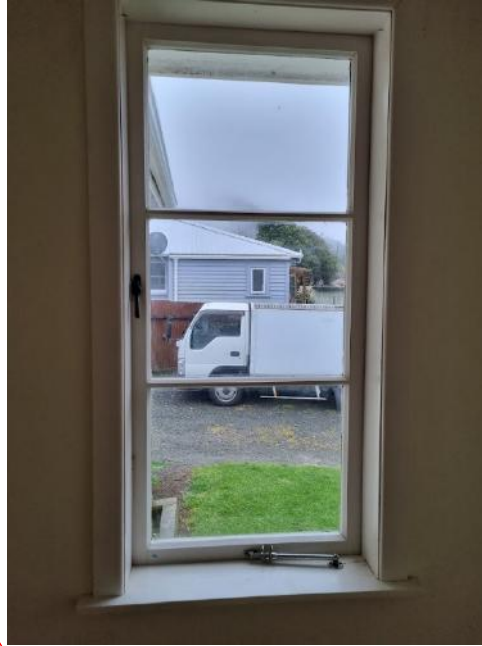
All windowsills throughout dwelling require maintenance and paint – splitting to the sills

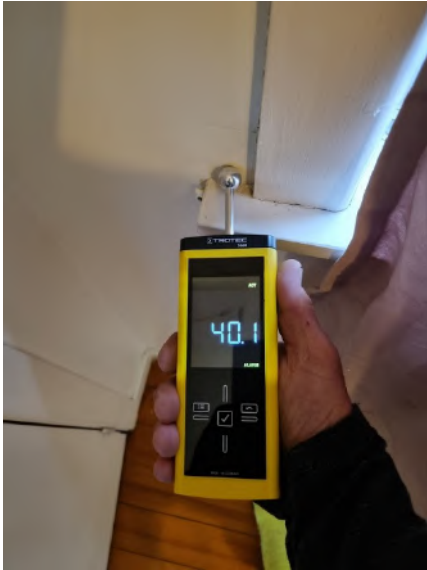
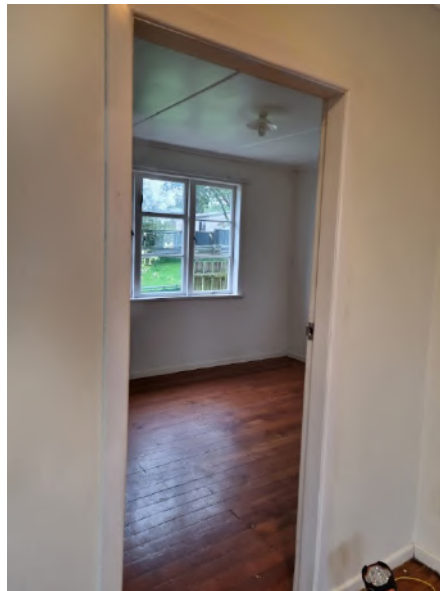
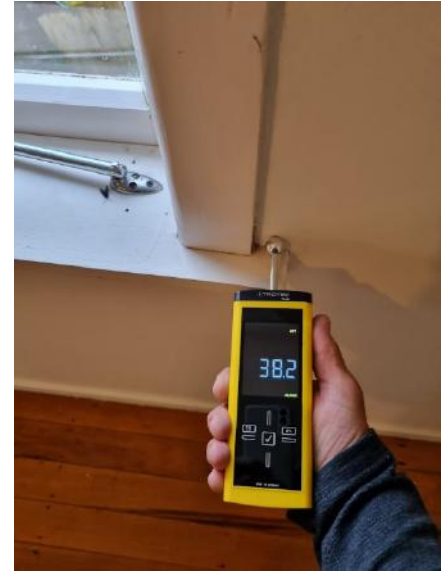
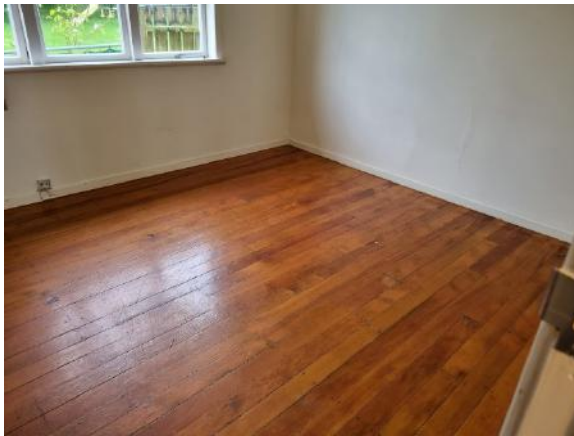
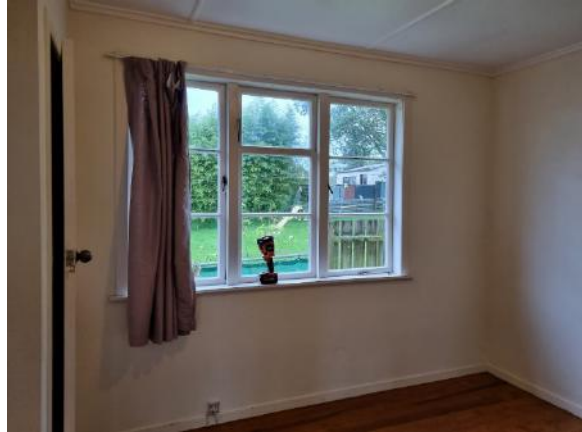
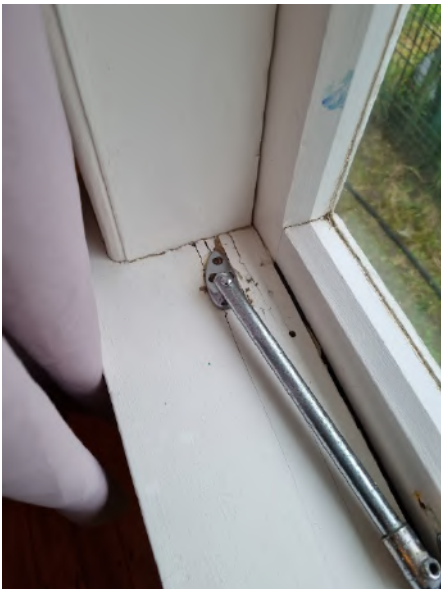
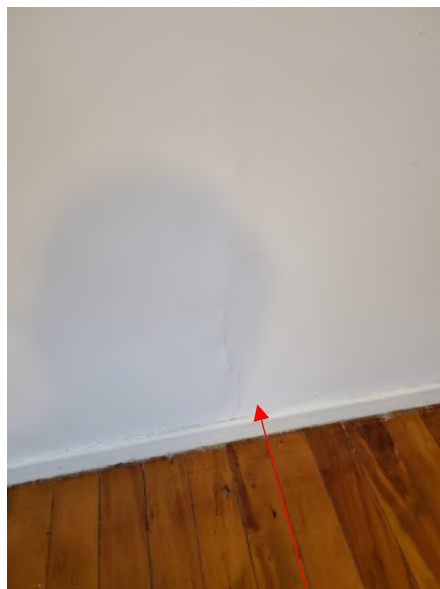
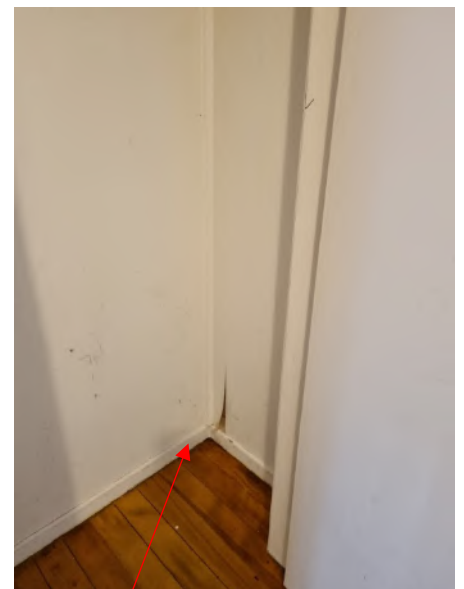
Bedroom 1

All window sashes throughout dwelling require maintenance

Possible historic water ingress in bedroom 1, issues present to the west wall

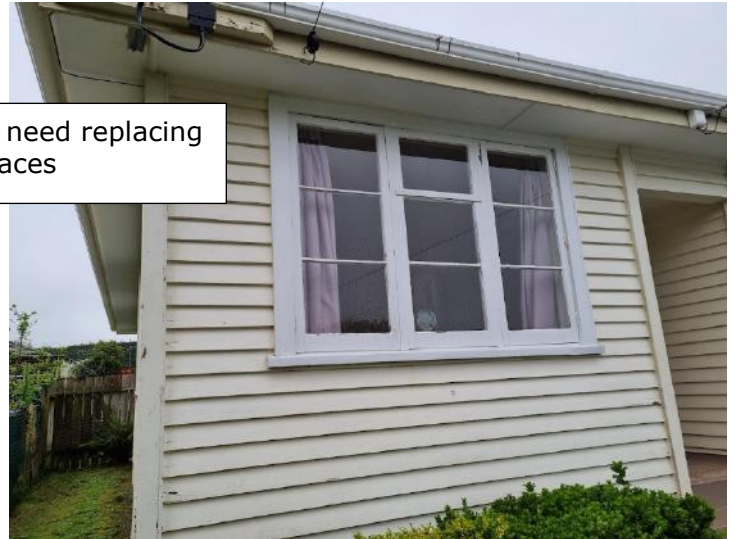
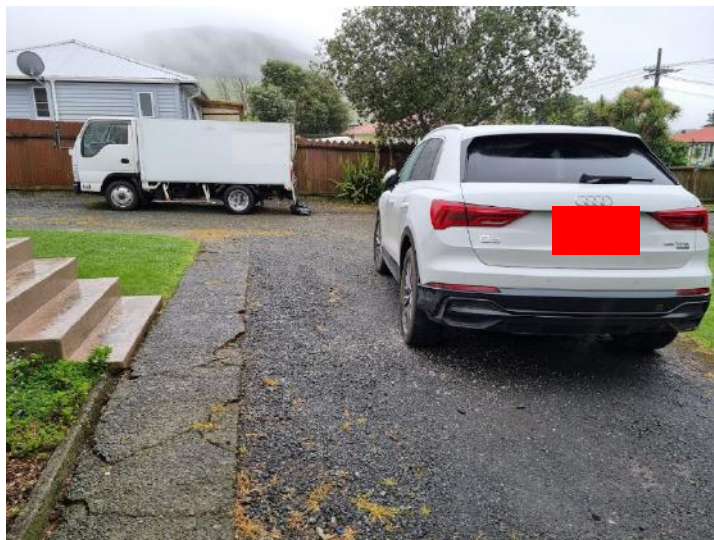
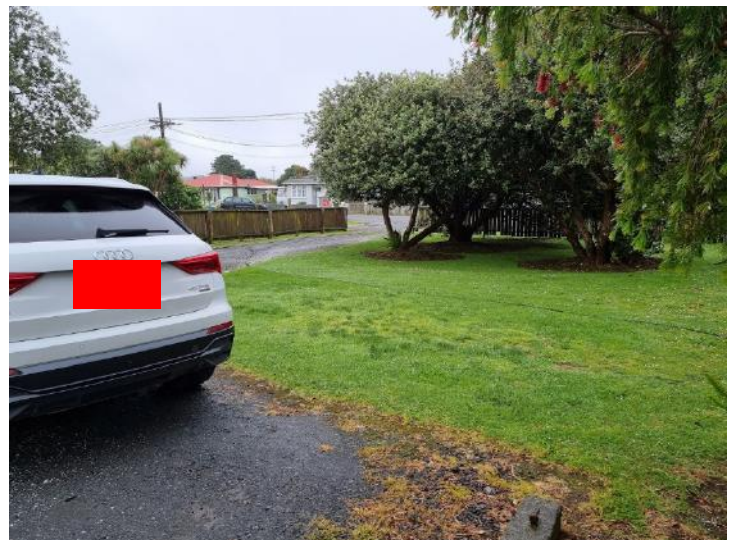
Weatherboards need replacing in places

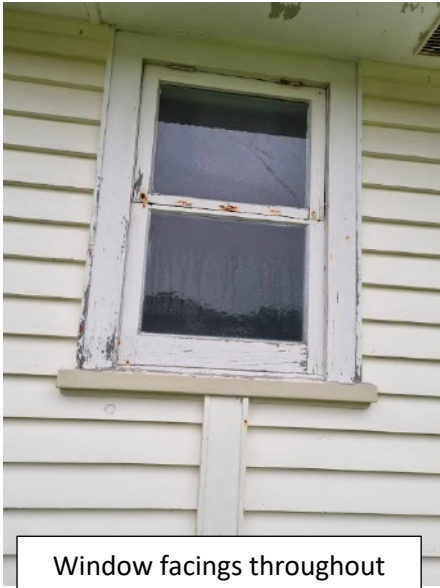
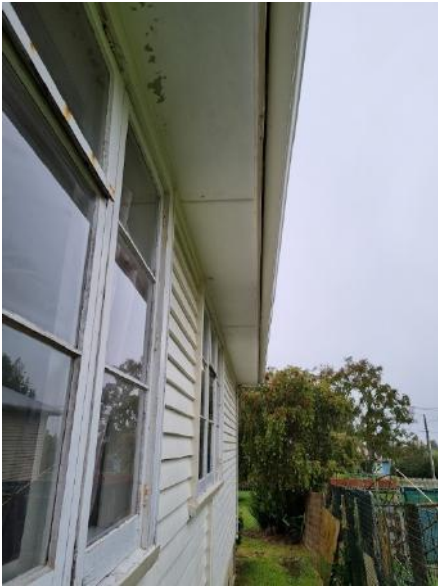
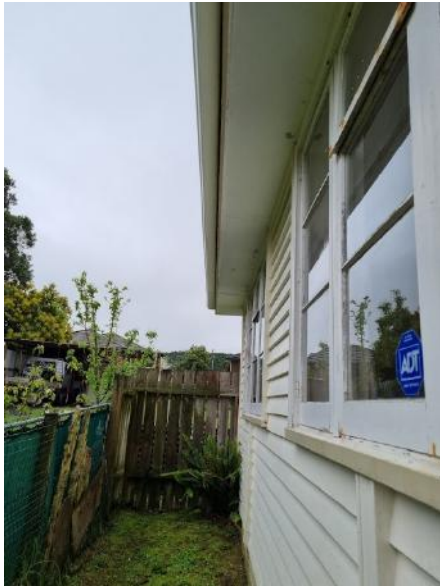
Window facings and frames, soffits, and weatherboards need painting
